# River Valley Home Inspections LLC

David M. DeSimone  
ID: Board Certified and Licensed in NH and VT  
244 Town Shed Road  
Orford, NH 03777

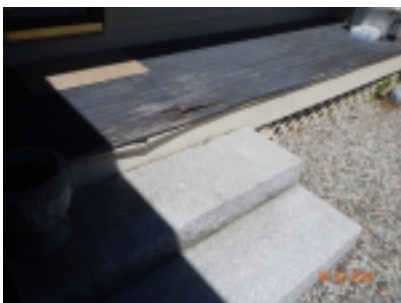
~Primary Entrance Porch Decay: Assessment identified areas of decayed wood within the primary entrance porch and landing assembly; Wood rot compromises structural integrity and creates an unsafe walking surface; It is recommended that a qualified contractor evaluate the porch structure to reconstruct the landing, to include replacing all decayed wood elements and any damaged floor joists below the decking to ensure a safe and stable assembly.

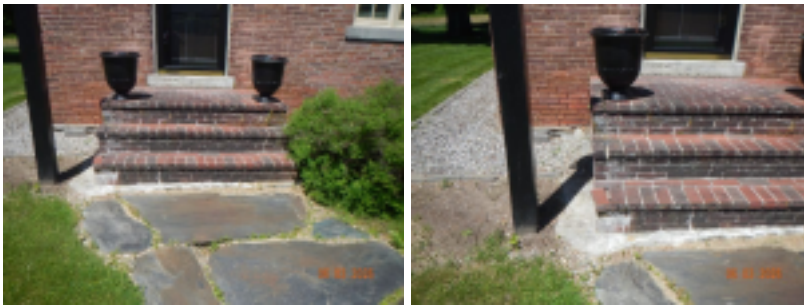
~Loose Brick Entry Steps: Assessment identified loose bricks, tall risers, and structural deterioration at the front entry steps, affecting the transition onto and off the stairs; Unstable masonry and improper step dimensions create an uneven stepping rhythm and a direct trip and fall hazard; It is recommended that a qualified mason evaluate the front steps to reconstruct the assembly, ensuring uniform riser heights, secure masonry, and a safe transition.

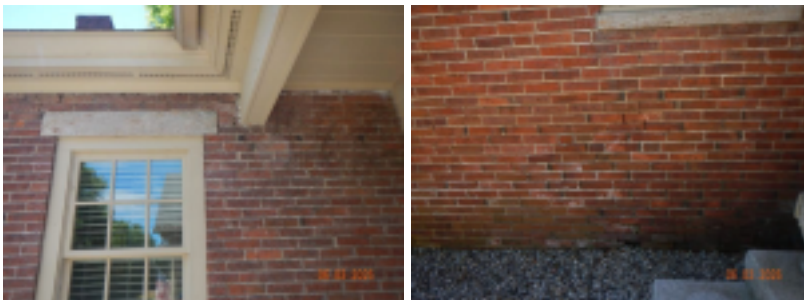
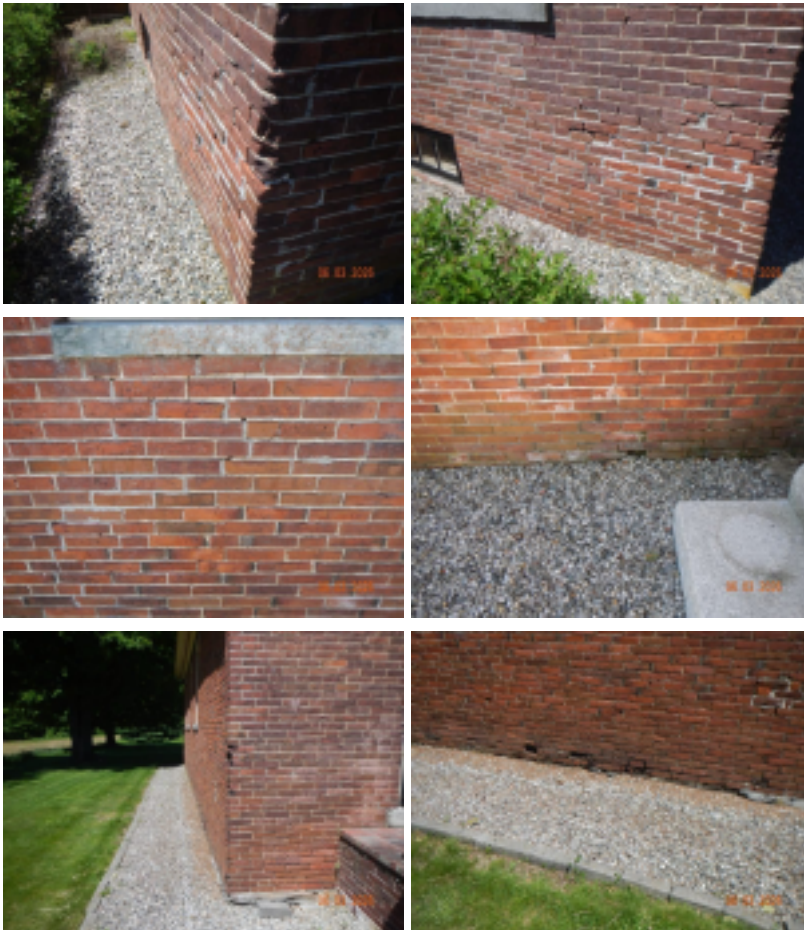
~Brick Pointing and Maintenance (Antique Home): Observation of the brick exterior identified worn mortar joints and damaged bricks resulting from spalling and moisture freeze-thaw cycles; On a home of this age, brick pointing and repair are ongoing maintenance requirements due to the original soft brick and sand based mortar; It is recommended the home be fully reviewed and the impacted surfaces professionally repaired and repointed using a historically appropriate high-lime mortar mix (such as Type O or Natural Hydraulic Lime) to replace damaged bricks, protect the building's weather envelope, and prevent localized masonry damage.

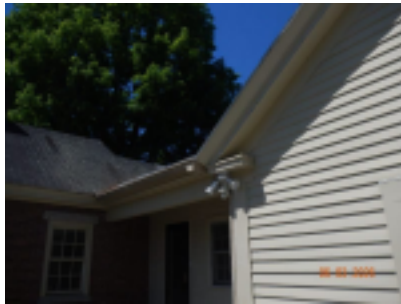
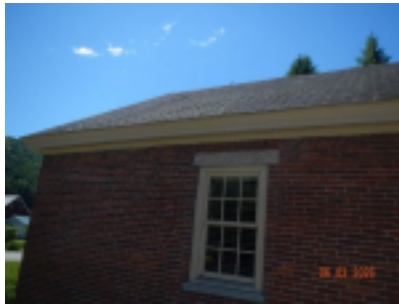
~Eave and Soffit Openings: Assessment identified gaps and open holes along the eaves and soffits; Unsealed openings compromise the building envelope and allow pests, wildlife, or moisture to enter the structure; It is recommended that a qualified contractor seal all openings along the eaves and soffits to prevent pest entry and moisture intrusion while maintaining proper attic ventilation pathways.
