# River Valley Home Inspections LLC

## REPORT DEFINITIONS

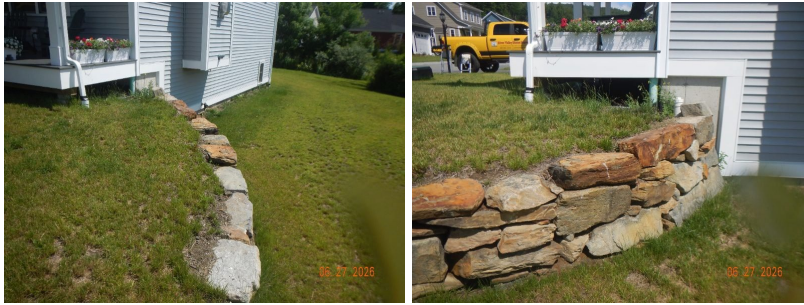
~Retaining Wall Guardrail Missing: Observation identified a retaining wall drop-off that lacks a safety guardrail or protective barrier; This unprotected drop creates a fall hazard, particularly at night or during low-light events; It is recommended that a qualified contractor evaluate the area and install an approved guardrail system to ensure occupant safety.

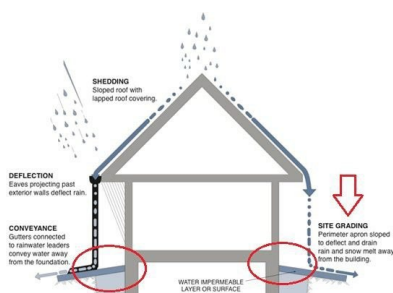
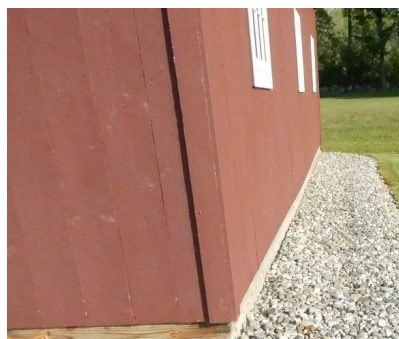
~Ongoing General Grading Needs: The grade along the perimeter of the home is an important factor in keeping moisture away from homes and allowing water to flow away from the home's siding, sills and foundation; A plan should be implemented to upgrade the current grading along the foundation including the walk out door area if present and any planting beds of the home; Grading first with vapor barrier with stone on top should be added to allow water to flow away from the foundation and limit dirt and water splashing onto the siding of the home; The top of the stone border should be at least 6 inches below the edge of the siding when establishing the grade of 5/8th inch pitch per foot fall and/or drained to move water away from the foundation; If unseen decay is discovered in the course of grading improvements, any impacted siding will need to be addressed to include ensuring the sill and wall studs are intact behind the siding.

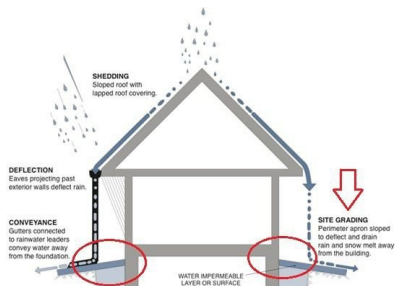
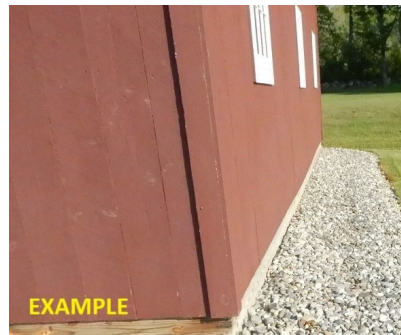
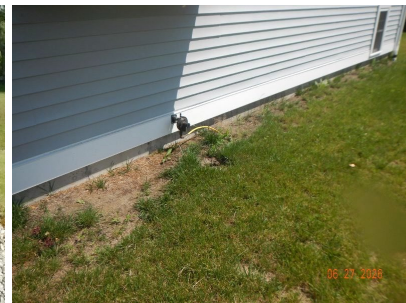
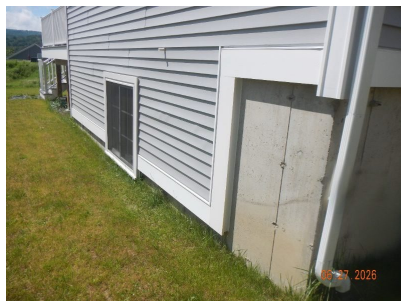
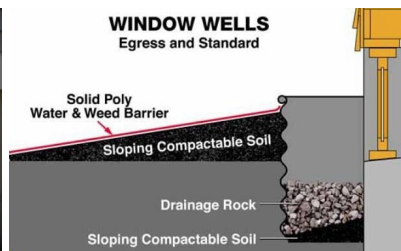
~Home Grading Needs: The grade along the perimeter of the home is an important factor in keeping moisture away from home and allowing water to flow away from the home's siding, sills and foundation; A plan should be implemented to upgrade the current grading along the foundation: Grading first with vapor barrier with stone on top should be added to allow water to flow away from the foundation and limit dirt and water splashing onto the siding of the home; The top of the stone border should be at least 6 inches below the edge of the siding when establishing the grade of 5/8th inch pitch per foot fall and/or drained to move water away from the foundation.

~Rear Grading and Window Well Improvements: Observation identified that grading corrections are needed near the basement window area to prevent water pooling; A proper window well should be installed as part of these drainage improvements to keep soil and surface moisture away from the window frame; A qualified landscape contractor should be engaged to complete these corrections to ensure proper water shedding and protect the foundation.

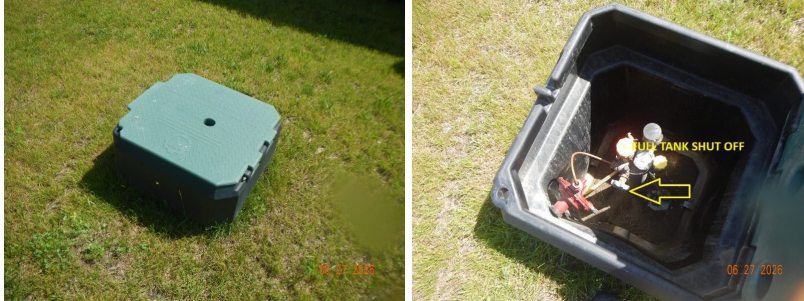
~Propane tanks and their associated delivery systems are considered outside the scope of a standard home inspection; It is recommended that the propane delivery company be contacted to confirm the tank's lease or ownership status and to perform an annual safety evaluation; This professional review should verify the condition of the tank, all interior and exterior supply lines, shutoff valves, and regulators; It is essential for the provider to confirm that the regulators have proper venting protection and that the system is appropriately shielded from falling snow or ice; All safety checks and maintenance should be documented by a certified technician in accordance with manufacturer recommendations and state safety standards.

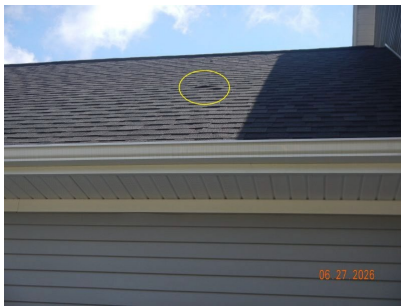
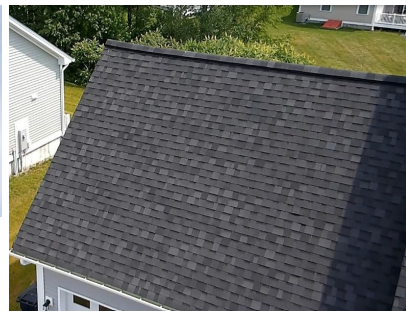
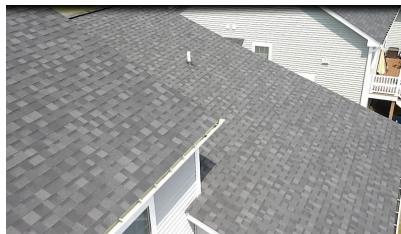
~Front Roof Above Garage Lifted Roof Shingles: Observation identified lifted shingles on the roof surfaces; This condition may be caused by backing-out fasteners or a failure in the factory adhesive strip; A qualified roofing contractor should be engaged to inspect these areas, reseal any loose nails, and properly adhere the shingles flat to protect the roof structure and building envelope.

~Slipped Roof Shingles At Peak Of Garage: Observation identified slipped shingles on the roof surfaces that have slid out of their original alignment; This condition exposes the underlying underlayment, creates an immediate pathway for water leaks, and compromises the building envelope; A qualified roofing contractor should be engaged to reposition the shingles, secure them with proper fasteners, and ensure the roof area is watertight.

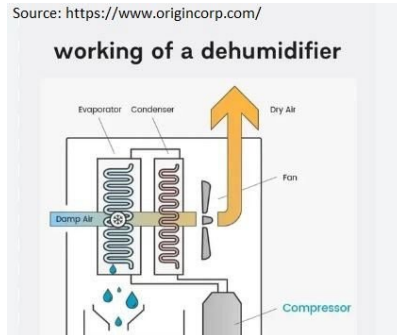
~Unit Observed: Dehumidifier: During the year, primarily in the summer months, ventilation and dehumidification of the basement/crawl space areas if present is recommended; Humidity levels maintained at 45% to 50% improve the overall living space conditions eliminating excess moisture generated in the basement.

~Unit Not Observed In Basement: Heat Recovery Ventilators (HRV's): Used primarily in cold climates, Heat Recovery Ventilators (HRV's) pass two air streams, one into the home from the outside and the other from inside the home to the outside reducing moisture and air impurities through filtration; To ensure optimal performance and air quality, the units will need to be maintained and operated per the manufacturer schedule to include washing of the filters, vacuuming, wiping down the units interior, and cleaning the exterior intake vents.

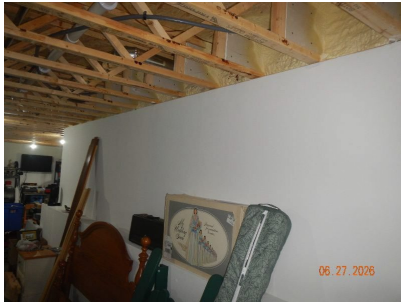
~Top Of Foundation Unprotected Spray Foam Insulation: The foam insulation installed in the basement is currently exposed and may lack a required thermal or ignition barrier; This creates a potential fire hazard as many foam products are combustible; A licensed insulation contractor should be consulted to determine if the specific product requires a fire-retardant intumescent coating or other protective covering to meet manufacturer's recommendations and current building standards.

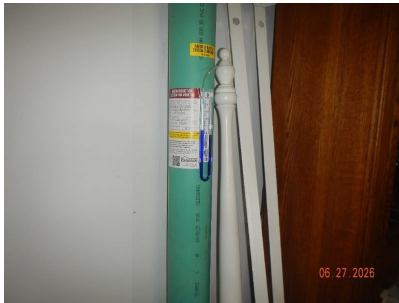
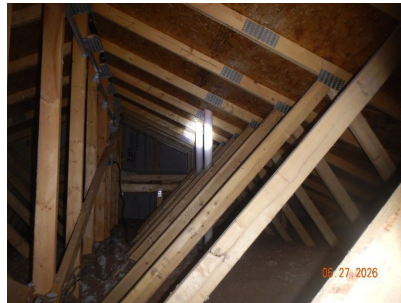
~Manometer Pressure Indicator Observed: The home is equipped with an operating Radon air reduction

system operating at a pressure of .4; The differential on the colored liquid indicates the system is running; If the liquid is equal, the system is not working; The system will need to be monitored to ensure the system is operating correctly; It is recommended a Radon air sampling be tested before taking possession of the home and a continuous Radon monitoring unit be installed, and lab testing be performed at least every 2 years to ensure the system in reducing Radon to safe levels and operating as designed.

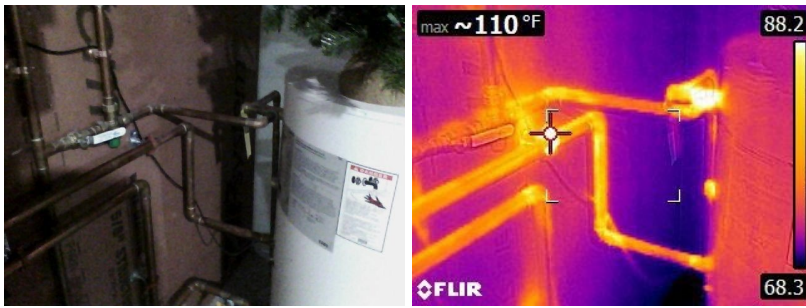
~Over time, mineral sediment from the water supply settles at the bottom of the tank; This buildup forces the heating elements to work harder, which reduces efficiency and can cause premature failure; for optimal performance and to prolong the life of the water heater, it is recommended that the tank be flushed annually to remove accumulated sediment; This maintenance task should be performed by a qualified licensed plumbing contractor.

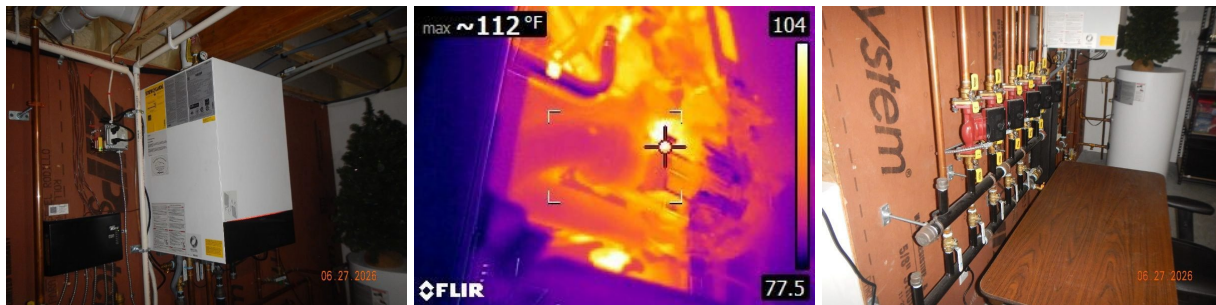
~Annual Propane Boiler Service and Maintenance: Review of the propane boiler noted that the unit was installed within the last year; It is recommended that a licensed heating contractor perform a full service and cleaning; This should include an inspection of the shroud, sensors, piping, and circulation pumps for proper operation, corrosion, or scale; Annual servicing and the use of available service plans is important for propane-fired boilers to ensure all mechanical and exhaust components remain in safe and satisfactory condition.

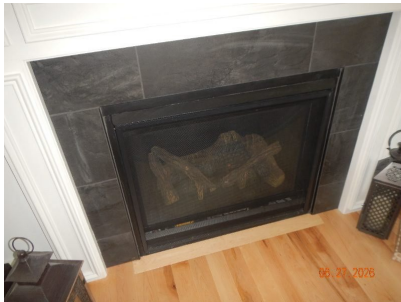
~Gas Fireplace Insert Cleaning and Service: Identification of the gas-fired fireplace insert confirmed the unit was operational at the time of the evaluation; As with any combustible fuel appliance, it is recommended that the unit be professionally serviced prior to the heating season; This maintenance should include a thorough vacuuming of dust below the unit, cleaning of the glass front, and a full inspection of all exhaust components to ensure they function safely; This professional tune-up is important to ensure safe, efficient operation and to protect the home's air quality.

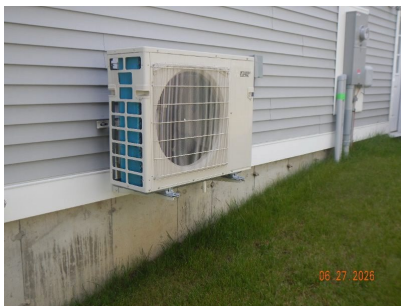
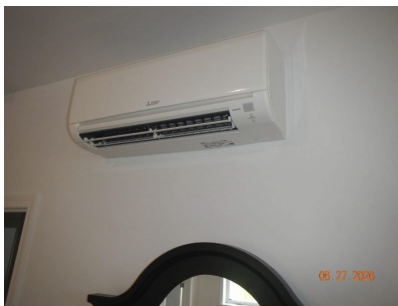
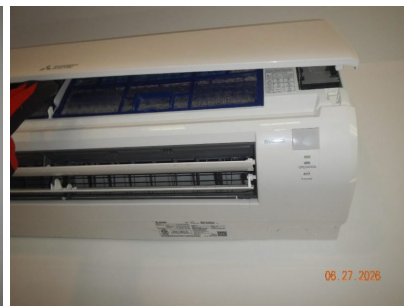
~Annual Heat Pump System Service: Observation of the property noted a heat pump system; It is advised that a qualified HVAC professional perform a comprehensive review of both the interior air handling unit(s) and the exterior condenser(s); This service should include cleaning and sanitizing the interior unit(s) and washing all filters, clearing the exterior coils of debris, and verifying proper refrigerant levels and condensate drainage; A full system maintenance is important for a buyer to ensure reliable, high-efficiency operation and to protect the longevity of the equipment.

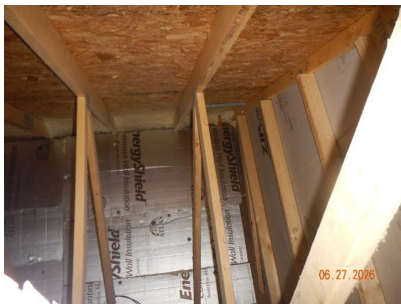
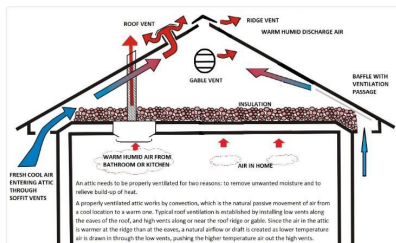
~First Floor Attic Ridge Vent Blockage and Exhaust Ventilation: Observation identified that the path to the ridge vent above the primary bedroom appears to be blocked by insulation board and spray foam insulation; This condition severely limits the exhaust ventilation out of the attic space and disrupts the necessary airflow and moisture balance; A qualified contractor should be engaged to review this area and, if necessary, clear the blockage or provide appropriate ventilation to ensure the attic is properly vented.
