# River Valley Home Inspections LLC

It was a pleasure completing your property inspection. As you will read, the inspection report consists of a detailed list of observations of different components and elements present in and outside the property with photographs of the property.

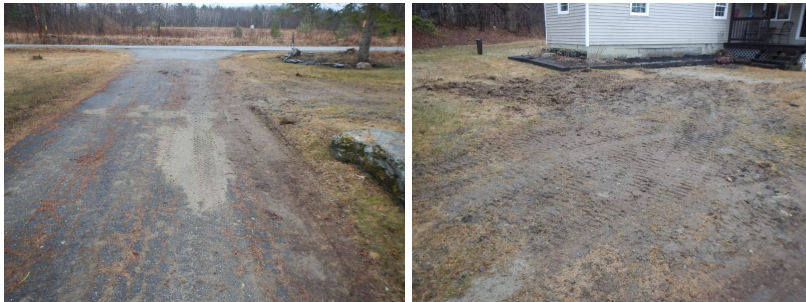
~Driveway Surface Renewal and Options: Observation of the driveway identified that the gravel and old asphalt surface has significantly deteriorated, resulting in muddy conditions and exposed soil; The current lack of stone coverage prevents proper drainage and leads to deep rutting during wet seasons; It is recommended that a professional paving or excavation contractor be consulted to explore options for either renewing the gravel surface or installing a full asphalt driveway; This evaluation is important to restore a stable driving surface and ensure long-term durability for the building's use.

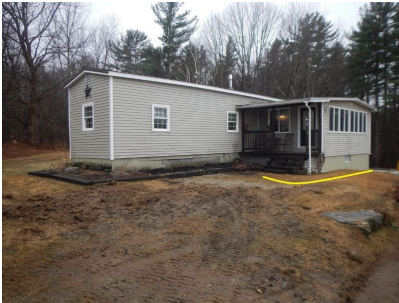
~Establishing Walkways: Observation of the home's exterior noted that permanent walkways are missing between the driveway and entry points; Establishing continuous walks allows people to move safely across lawns and open areas, especially during winter or rainy conditions; It is recommended that a qualified hardscape contractor be consulted to design and install stable walking surfaces to ensure a safe and reliable path of travel.

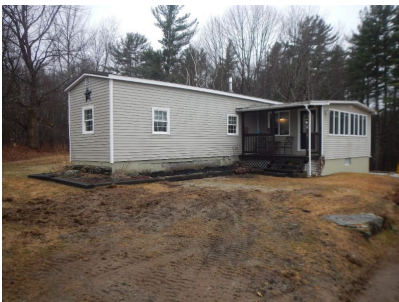
~Regrade Construction Activity: The front lawn needs to be properly graded and reseeded where construction activity has disturbed the soil; Lawns in this condition create tripping hazards when mowing or crossing the lawn.

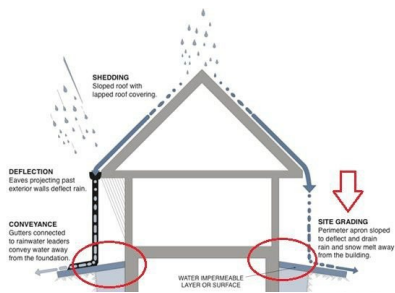
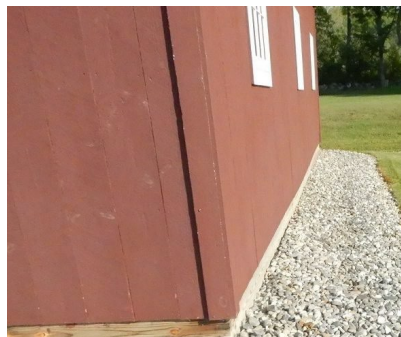
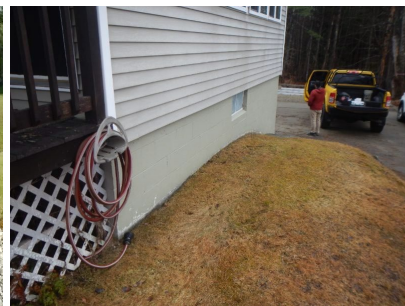
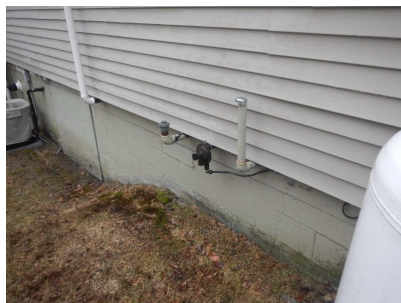
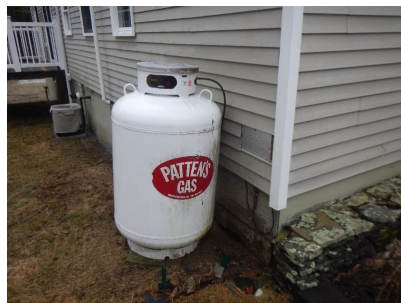
~General Grading Needs: The grade along the perimeter of the home is an important factor in keeping moisture away from homes and allowing water to flow away from the home's siding, sills and foundation; A plan should be implemented to upgrade the current grading along the foundation including the walk out door area if present and any planting beds of the home; Grading first with vapor barrier with stone on top should be added to allow water to flow away from the foundation and limit dirt and water splashing onto the siding of the home; The top of the stone border should be at least 6 inches below the edge of the siding when establishing the grade of 5/8th inch pitch per foot fall and/or drained to move water away from the foundation; If unseen decay is discovered in the course of grading improvements, any impacted siding will need to be addressed to include ensuring the sill and wall studs are intact behind the siding.

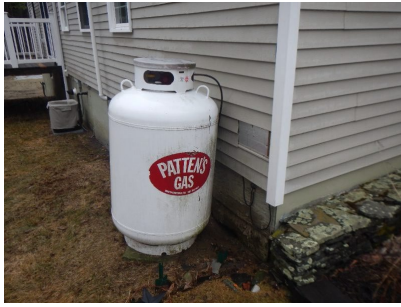
~Vinyl Siding Missing: Near Propane Tanks: Missing vinyl siding pieces were observed and will need to be installed.

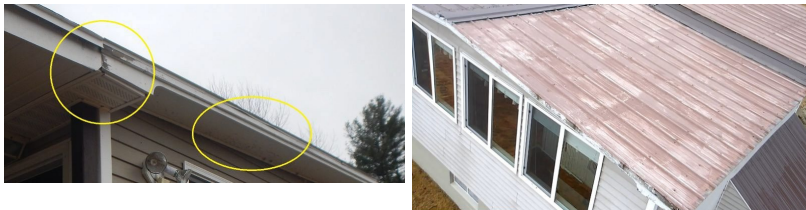
~Repair and Paint: Aged and exposed wood and paint conditions were observed along the window and door trim, the trim fascia board below the roof drip line, and the full soffit; To maintain the optimal protection of the home in these areas, it is recommended the trim, eaves and soffits of the home be reviewed and all decay repaired and repainted; After a full initial painting, painting will need to be completed on as needed or manufactures recommended cycle dependent on the paints condition; Please note: the wall sheathing, 2X4 wall studs, rafter ends, and any area behind the trim and trim fascia boards will need to be reviewed for damage when the areas are exposed and if damage is identified those items repaired; A full review of the homes perimeter needs to be performed and the repairs completed.

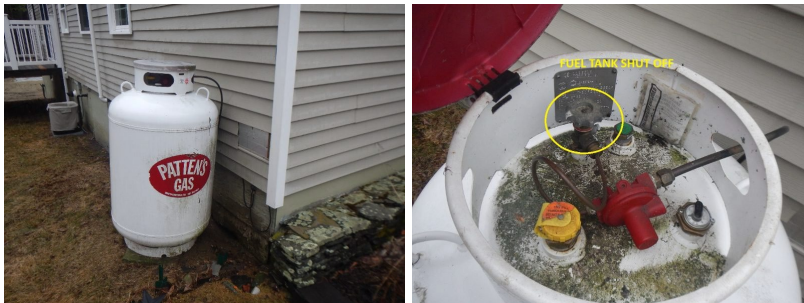
~Propane tanks and their associated delivery systems are considered outside the scope of a standard home inspection; It is recommended that the propane delivery company be contacted prior to the transfer of ownership to confirm the tank's lease or ownership status and to perform a comprehensive safety evaluation; This professional review should verify the condition of the tank, all interior and exterior supply lines, shutoff valves, and regulators; It is essential for the provider to confirm that the regulators have proper venting protection and that the system is appropriately shielded from falling snow or ice; All safety checks and maintenance should be documented by a certified technician in accordance with manufacturer recommendations and state safety standards before taking ownership of the system.

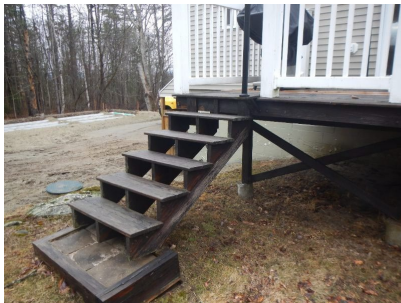
user stability and fall protection, modern safety standards require a graspable handrail and protective guards on both sides of the stairs when they reach this height; It is recommended that a qualified building contractor be consulted to install a graspable handrail and safety guards with openings no larger than 4 inches to meet current safety rules.

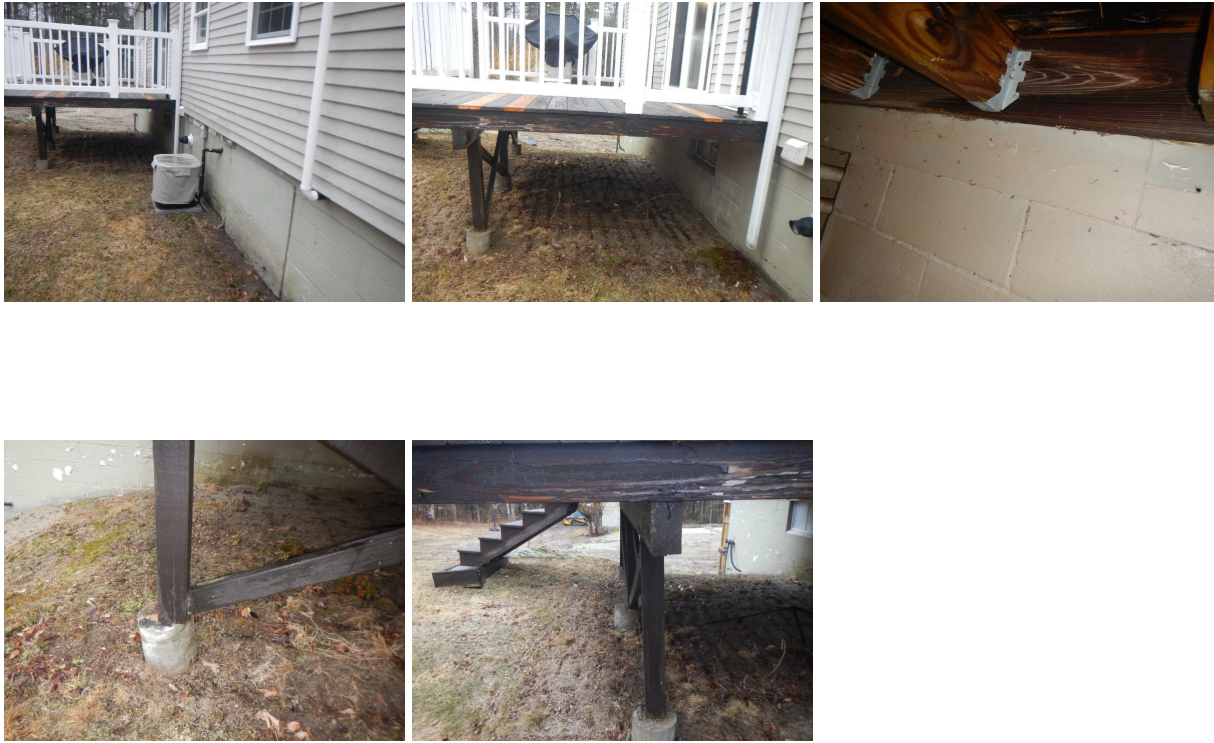
~Deck Ledger Flashing (Advisory): Observation of the deck-to-house connection identified that proper flashing is either missing or improperly installed; Flashing is a critical water-proof barrier (usually metal or plastic) that prevents water from getting trapped behind the deck board and rotting the house's structural framing; It is recommended that a qualified deck contractor be consulted to install (or confirm) approved flashing to ensure the connection is weather-tight and the house structure is protected from long-term water damage.

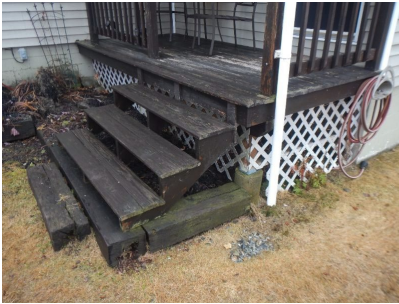
user stability and fall protection, modern safety standards require a graspable handrail and protective guards on both sides of the stairs when they reach this height; It is recommended that a qualified building contractor be consulted to install a graspable handrail and safety guards with openings no larger than 4 inches to meet current safety rules.

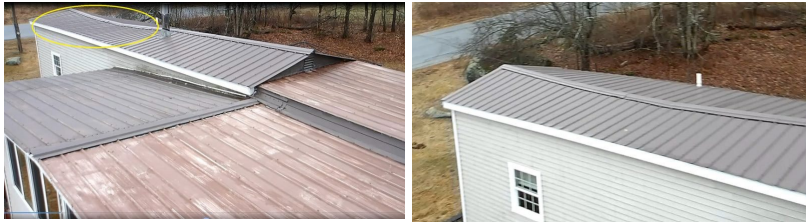
Ridge Line Sag

~Roof Ridgeline Sag: A significant sag was observed along the front portion of the roof; It is recommended the roof be professionally reviewed to determine and correct the cause of the observation to ensure the roof properly sheds rain and snow loading in the winter months.

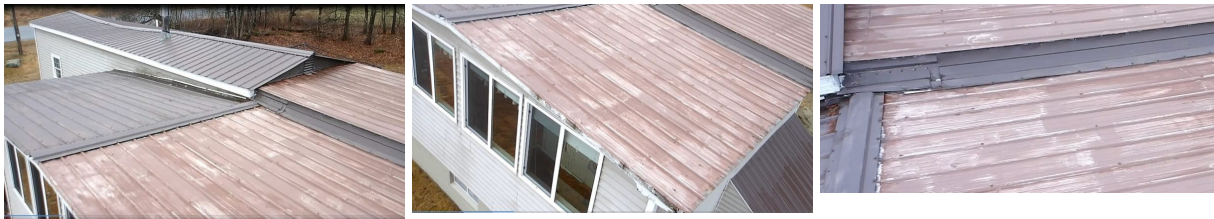
~Metal Roof Surface Sealing Evaluation: Observation of the metal roof assembly identified signs of aging, including fading paint surfaces on sections of the roof; While the roofing material appeared in generally good condition, the protective finish has begun to age; It is recommended that a qualified roofing specialist be consulted to perform a review of the seams and fasteners; This professional evaluation is important to determine if the roof is a candidate for a specialized resurfacing treatment to ensure long-term weather protection of the roof surface.

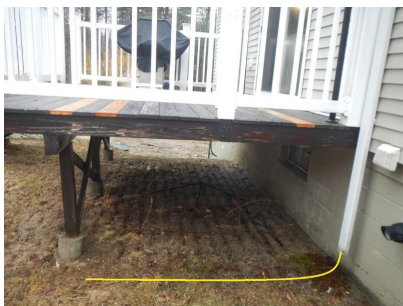
~Existing Gutter Extensions: Missing: Extensions are important to move water away from the foundation and will need to be added.

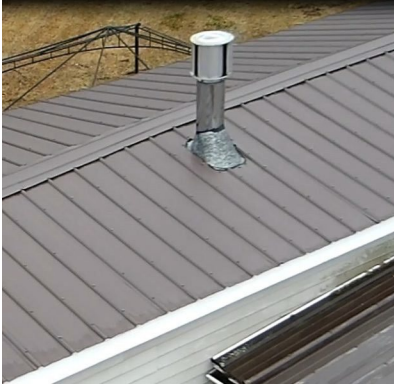
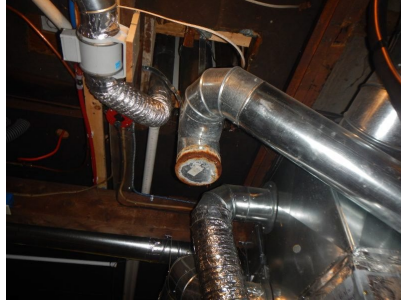
~Basement Rust Observed: Liner and Flue Safety: Identification of the combustion gas appliance(s) confirmed the need for a professional chimney inspection and cleaning; An important maintenance and safety step is verifying the presence and condition of a proper appliance exhaust; It is recommended that the exhaust be cleaned and fully inspected by a certified technician before taking possession of the home; The installation or repair of a line is necessary to ensure the safe venting of combustion gases.

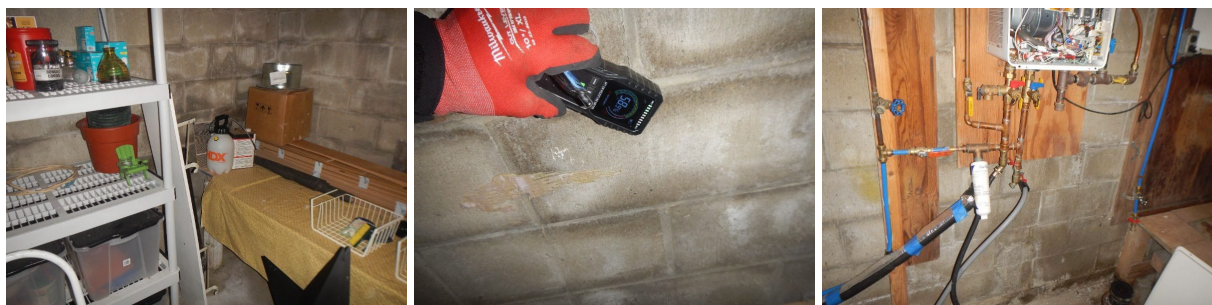
penetration occur during heavy rain or snowmelt; a professional basement waterproofing specialist should be consulted to evaluate further remedies to reduce its impacts.

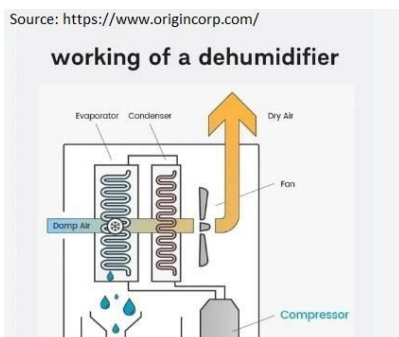
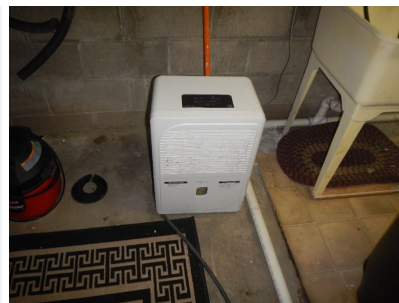
~It is recommended that dehumidification and air exchange be added to the basement and crawlspace after corrections to reduce moisture in the basement and crawlspace are implemented.

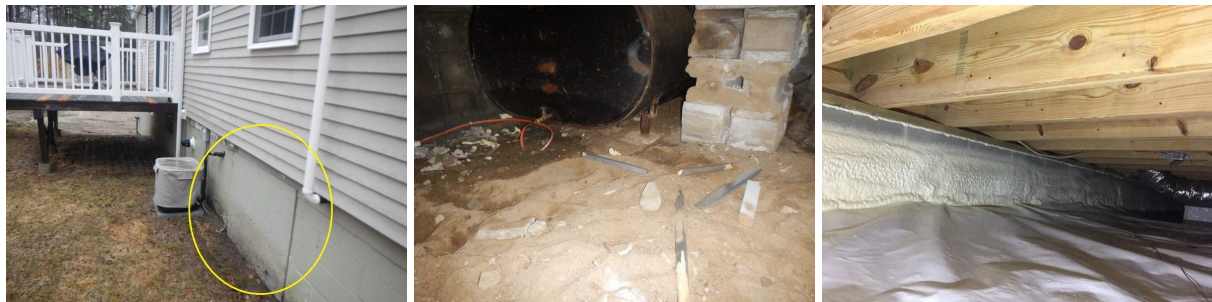
~Dirt Floor Vapor Barrier and Encapsulation: Observation of the crawlspace identified a moist dirt floor that is contributing to elevated humidity levels within the basement; To mitigate moisture evaporation, it is recommended that the floor be cleared of all debris and a high-quality, durable vapor barrier be professionally installed; For maximum protection, a full encapsulation of the crawlspace—to include sealing the walls and floor—is recommended to create a conditioned, dry environment; This professional upgrade is essential to prevent organic growth, protect the floor framing from rot, and significantly improve the overall air quality of the home.

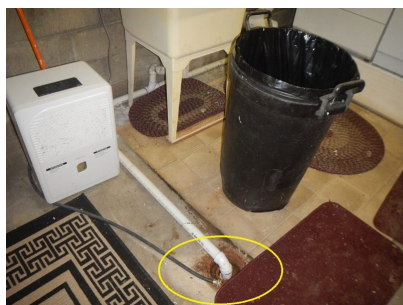
~Basement Floor Drain Evaluation: Identification of the basement area disclosed the presence of a floor drain; The drain was not tested as part of the home inspection scope due to the risk of water damage if the system fails to operate; It is recommended that a licensed plumbing or septic professional be consulted to scope the line and locate the exterior discharge point; This professional review is necessary to ensure the drain remains clear of vegetation or pest obstructions; Yearly maintenance is essential to ensure the exit point remains unobstructed.

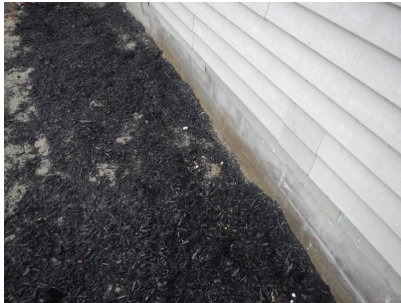
~Exterior Foundation Repair: Observation of the foundation near the entrance identified that a repair has been performed; It is recommended that the buyer request documentation from the seller regarding the nature of the repair and any transferable warranties for the building's records.

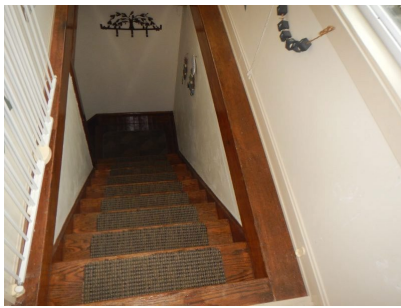
~ Non-Standard Stair Riser and Tread Ratios: Evaluation of the staircase revealed that the riser heights and tread depths (runs) are inconsistent or do not meet standard safety ratios; It is recommended that a qualified building contractor be consulted to evaluate options for bringing the staircase into alignment with modern safety standards.

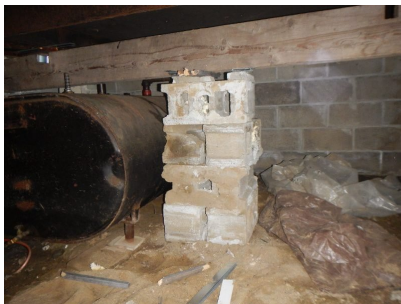
~The improperly installed block pier in the crawlspace needs to be replaced with an approved pier and post to properly support the structure over time.

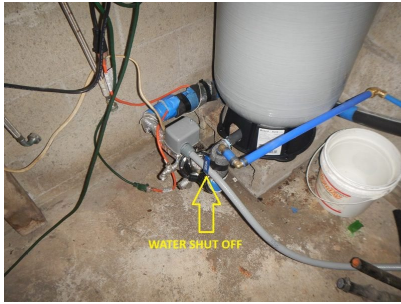
~Well: Pressure Tank, Cleanup, Cold Water Pipe Insulation and Catch-pan: If not completed, all dirt and debris and any nonessential items should be removed from around the homes water system; Condensation generated from cold water pipes and humid room conditions, common in this area, drip onto floors and drop ceilings if installed; Insulating cold water pipes and adding a drip catch pan below the well pump pressure gauge and piping area at the base of the tank will help lessen this impact.

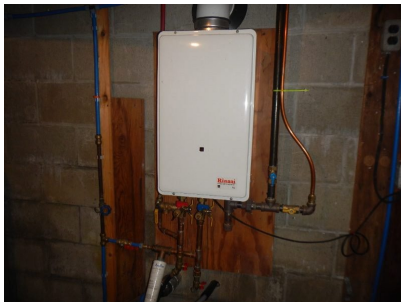
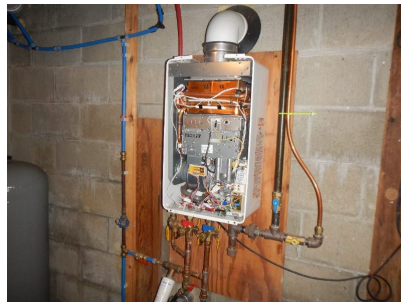
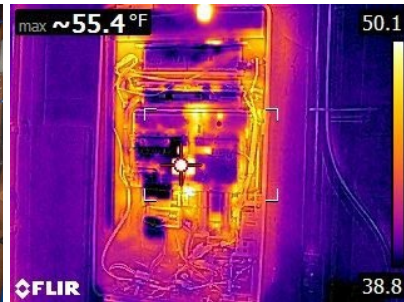
~Missing Extension Pipe: The Extension pipe used to direct scalding water away from individuals in the event of a safety relief valve release and connected to the relief valve of the water heaters is missing and has to be installed within 6 inches of the floor surface.

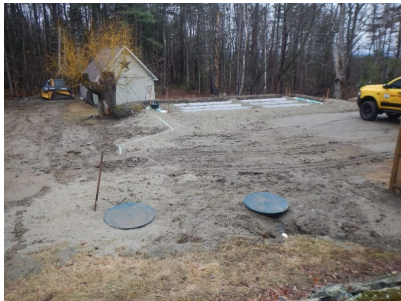
~New System: A new septic system is being installed; The contractor name, contact info and all warranties and guarantees should be provided and retained for your records.

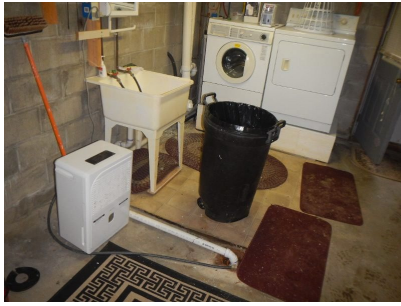
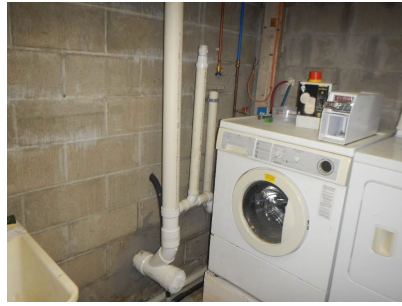
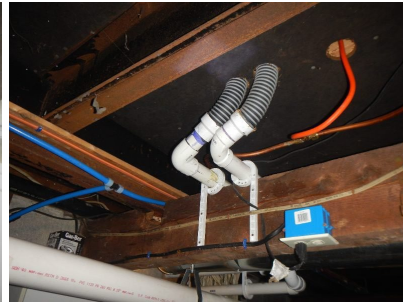
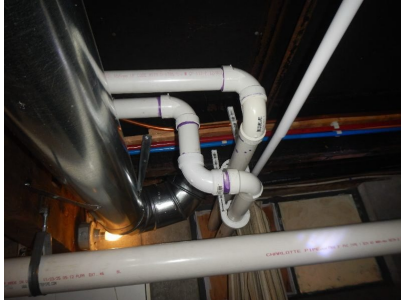
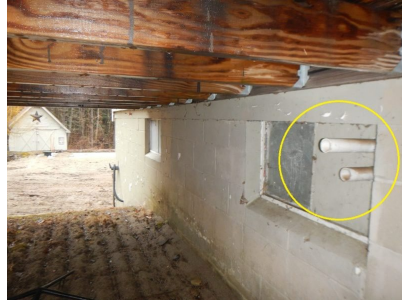
~The function of the two PVC lines running into and out of the basement need to be traced and their identified to ensure they are properly installed for their intended use.

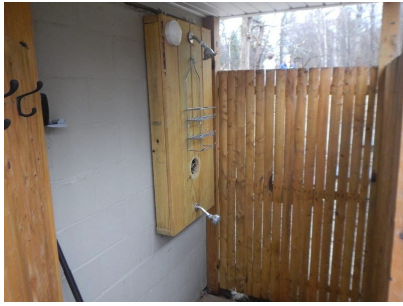
~The exterior shower has been winterized; After the weather warms, the unit will need to be connected and tested to ensure the unit is not leaking.

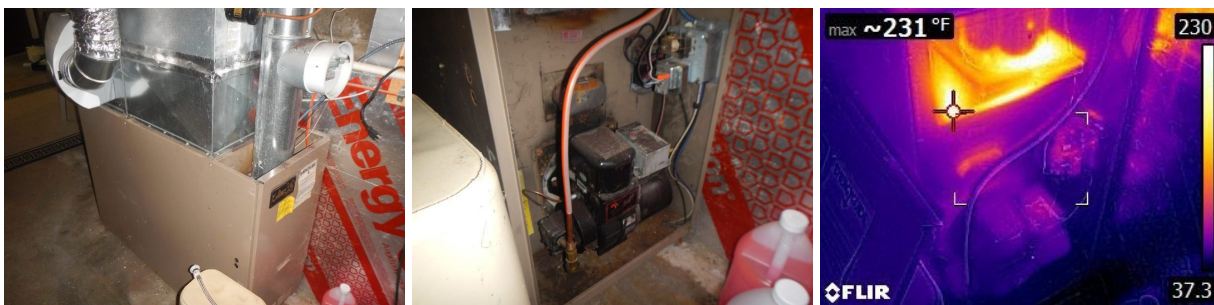
IR Furnace Operation Heat Tracing

~2026 and 2027 Heating Season: Last service date tag- Not Determined: The furnace fired and ran during the inspection process; Before taking possession of the home, the furnace will need to be fully cleaned and serviced and then on a yearly basis going forward; The shroud, and all connecting pipes need to be cleaned of any debris and the interior vacuumed and the unit wiped down to eliminate dirt and debris on the furnace surfaces; Oil fired furnaces need to be serviced yearly; Some customer elect to purchase yearly maintenance or home warranty plans (if available due to the age of the unit) to cover cleaning, emergency response and repair and replacement needs if required; The current service company, local fuel delivery companies, or a web site search of home warranty programs should be contacted if a specific plan is desired.

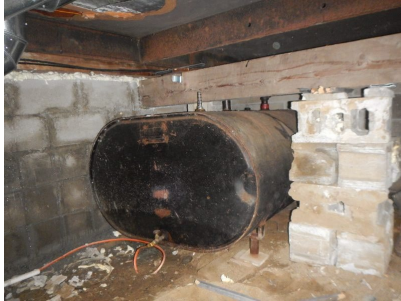
~New Hampshire Oil Tank Service (Advisory): Observation of the heating system noted that some current New Hampshire oil tank requirements may not be met; It is important to have the oil delivery company verify the tank's condition before taking possession or switching providers; Often, companies will fail existing tanks or fill line setups when a new customer starts service; It is recommended that the oil delivery company be contacted to inspect and sign off on the tank's condition for continued delivery.

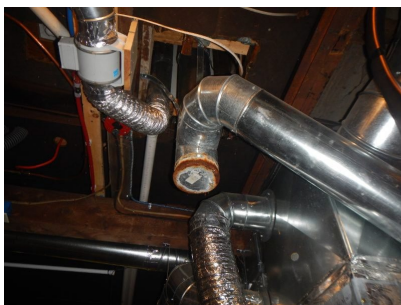
~Furnace Exhaust Condensation and Rust: Observation of the furnace exhaust venting identified visible rust and signs of condensation damage; This typically occurs when exhaust gases cool too quickly, leading to acidic water buildup that eats through the metal; Over time, this can lead to dangerous exhaust leaks or equipment failure; It is recommended that a licensed HVAC technician be consulted to replace the damaged venting and determine the cause of the condensation to prevent future rusting.

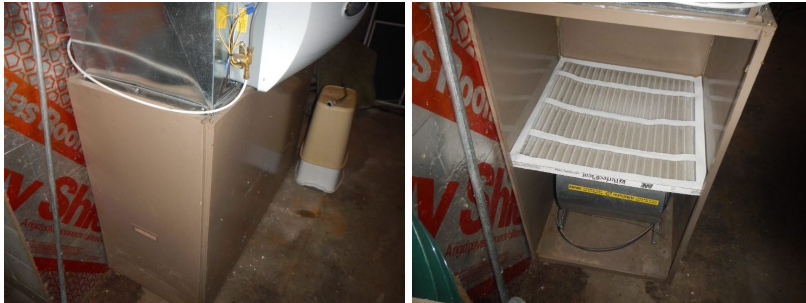
~Filter Change and Fan Housing Cleaning: Electric power to the unit will need to be turned off before any work is completed in the filter compartment of the heater; Air filters should be changed per manufacturer suggested periods to ensure proper air flow and air filtration in the home; The full space and all fan components should be cleaned and vacuumed to remove debris; Companies that will clean the ductwork of dust and danger and debris accumulated over the years in the duct work are available.

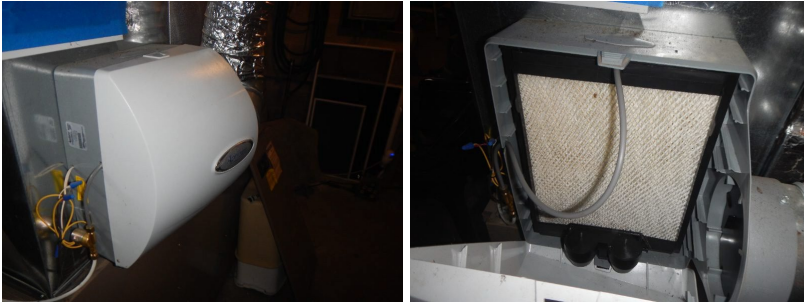
~Humidifier Maintenance and Service: Observation of the heating system identified an attached humidifier unit; Humidifiers require regular upkeep, such as cleaning and filter replacement, to prevent mold growth and ensure they work efficiently; It is recommended that a licensed HVAC technician perform a full service on the unit in accordance with the manufacturer's specifications to confirm it is operational.

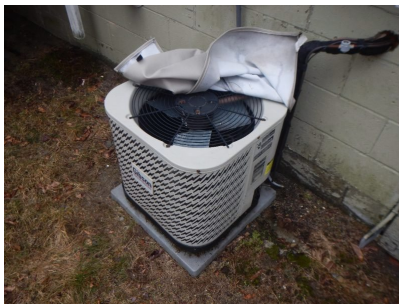
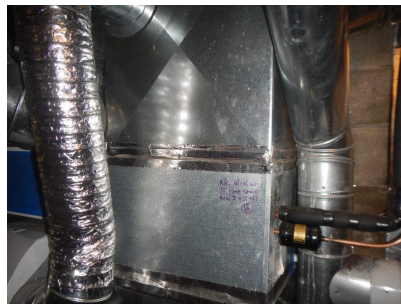
~Central Air Conditioning Maintenance: Review of the central air system revealed no record of the last service date; Because yearly maintenance is vital for the system's longevity and performance, it is recommended that a heating and air conditioning service company be contacted to fully service the unit to include the interior evaporative coil system to ensure the system is operating a full efficiency before you take possession of the system.

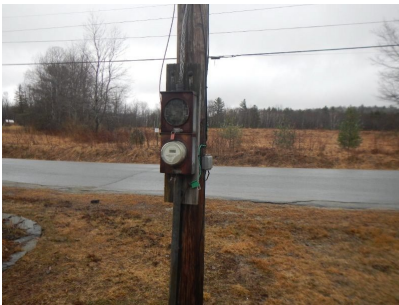
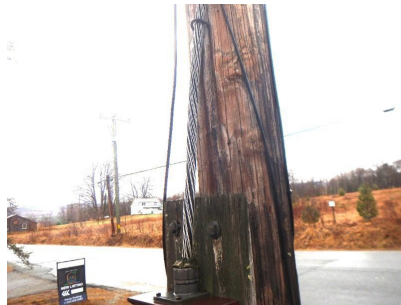
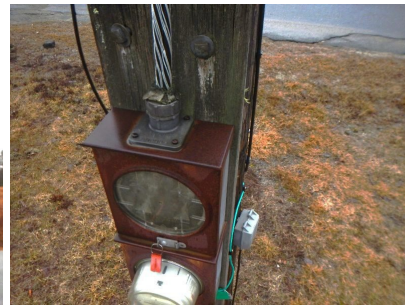
~Deteriorated/Damaged Sheathing And Rusted Connections: The protective cover installed on the service entrance cable has deteriorated allowing weather to penetrate the meter panel and may impact the electrical service over time; The local utility should be contacted to determine responsibility including the full inspection of the utility sealed interior meter panel to ensure rust and corrosion has not damaged the internal connections.

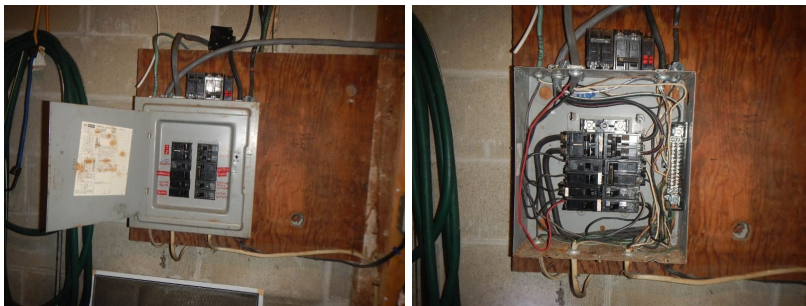
~Surge Protection for Sensitive Equipment: Evaluation of the electrical system revealed that a Surge Protective Device (SPD) is currently missing; Modern homes contain sensitive electronics and appliances that are vulnerable to high-voltage spikes; It is recommended that a whole-house surge protector be installed within the panel to mitigate the risk of damage from external power surges.

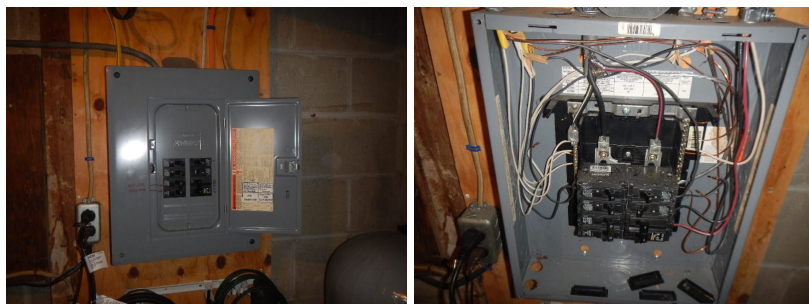
~AFCI Circuit Breaker Protection Recommendation: An arc-fault circuit interrupter (AFCI) also known as an arc-fault detection device (AFDD) is a circuit breaker that breaks the circuit when it detects an electric arc in the circuit it protects to prevent electrical fires; AFCI protection is currently required for new construction of all 15 and 20 amp branch circuits providing power to outlets in residential family rooms, dining rooms, living rooms, parlors, libraries, dens, bedrooms, sunrooms, recreation rooms, closets, hallways, and similar rooms or areas.

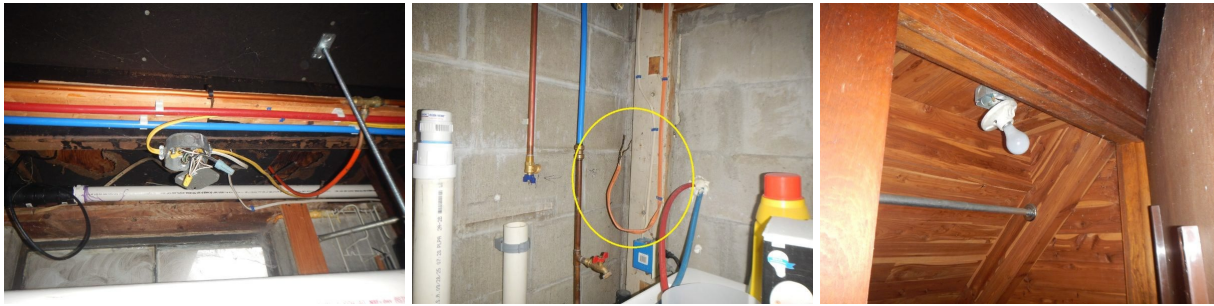
~Th closet light needs to be properly installed to include the addition of a bulb cover.  
~Floating Wire(s): All conductors need to be properly secured; Floating wires were observed and need to be corrected with approved staples or holders.
