# River Valley Home Inspections LLC

David M. DeSimone  
ID: Board Certified and Licensed in NH and VT  
244 Town Shed Road  
Orford, NH 03777

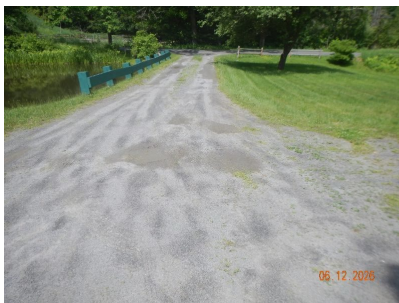
~Gravel Driveway Maintenance: Observation of the gravel driveway identified areas of thinning material; It is recommended that a qualified landscape contractor be consulted to regrade the surface to allow water to shed to the sides; Additionally and where required, a fresh stone top-dressing should be applied and compacted to ensure a stable, long-lasting driving surface.

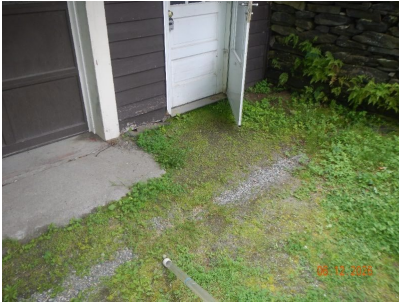
~Missing Primary Entrance Landing: Observation of the primary entrance identified that the step lacks a proper landing; It is advised that a qualified building contractor perform a professional review to explore options for installing a landing; Ensuring a level landing at the door is important to meet current building standards and provide a safe transition into the home.

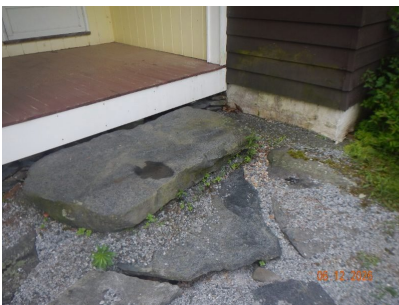
~Exterior Stair Riser Height Safety: Observation of the stone stairs noted a tall riser height, likely caused by settlement of the stone step; It is necessary for a qualified mason or hardscape specialist to reset the stones and level the surface to eliminate this discrepancy; Correcting the riser height is important to remove a tripping hazard and to ensure the stairs provide a safe and uniform transition.

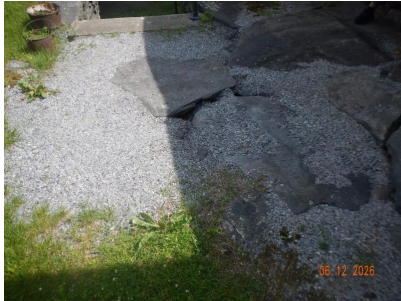
~Stone Walkway Maintenance: Observation of the stone walkways identified uneven surfaces and settled stones; These conditions can create trip hazards and affect drainage; It is recommended that a qualified contractor be consulted to review and level the walkways to ensure a safe and stable path.

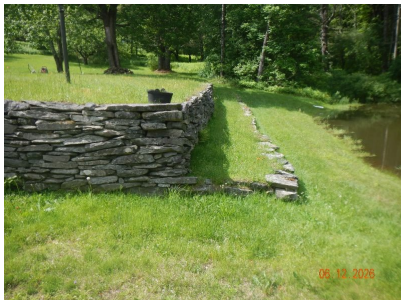
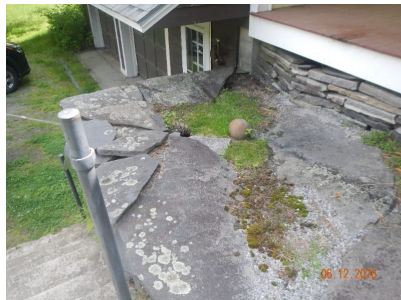
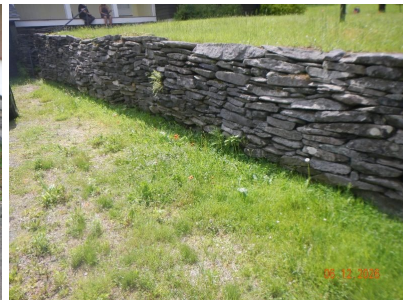
~Stone Retaining Wall Movement: Observation identified areas where the stone wall is leaning or shifting forward over time; This condition is caused by soil pressure and frost heaving due to poor drainage behind the stones, which traps moisture and creates pressure; It is recommended that a qualified mason or contractor excavate behind the wall, reset the stones, and install proper backfill and drainage systems to divert water away from the wall.

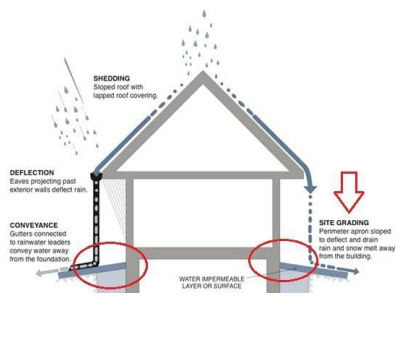
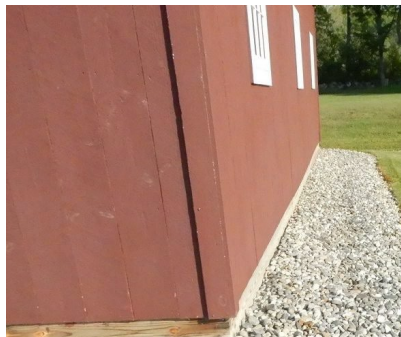
~Ongoing General Grading Needs: The grade along the perimeter of the home is an important factor in keeping moisture away from homes and allowing water to flow away from the home's siding, sills and foundation; A plan should be implemented to upgrade the current grading along the foundation including the walk out door area if present and any planting beds of the home; Grading first with vapor barrier with stone on top should be added to allow water to flow away from the foundation and limit dirt and water splashing onto the siding of the home; The top of the stone border should be at least 6 inches below the edge of the siding when establishing the grade of 5/8th inch pitch per foot fall and/or drained to move water away from the foundation; If unseen decay is discovered in the course of grading improvements, any impacted siding will need to be addressed to include ensuring the sill and wall studs are intact behind the siding.

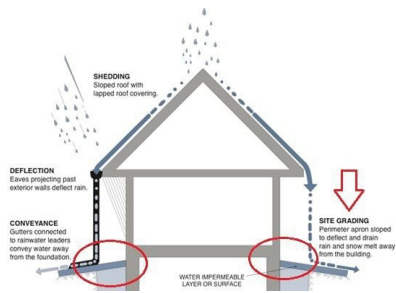
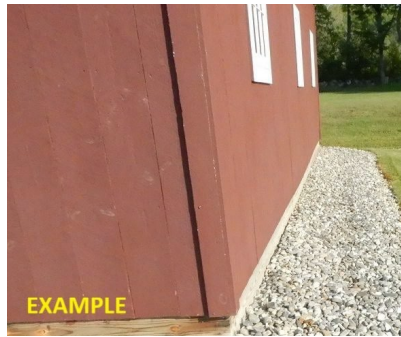
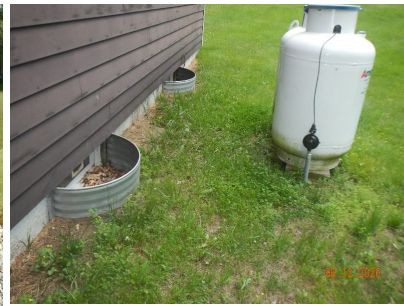
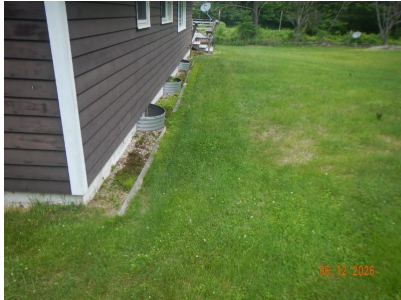
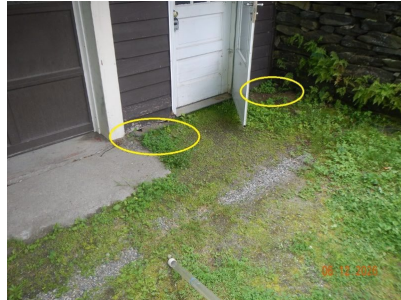
~Ongoing General Grading Needs: The grade along the perimeter of the home is an important factor in keeping moisture away from home and allowing water to flow away from the home's siding, sills and foundation to include the area at the lower entrance door; A plan should be implemented to upgrade the current grading along the foundation: Grading first with vapor barrier with stone on top should be added to allow water to flow away from the foundation and limit dirt and water splashing onto the siding of the home; The top of the stone border should be at least 6 inches below the edge of the siding when establishing the grade of 5/8th inch pitch per foot fall and/or drained to move water away from the foundation.

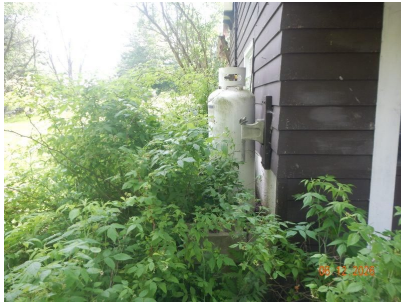
~Maintain/Remove Vegetation: All vegetation and tree branches within at least 2 feet of the home (6 feet is preferred) needs to be removed; Vegetation close to homes allows moist conditions to form along the home promoting decay and algae growth as well as harboring pest that may find their way into the home.

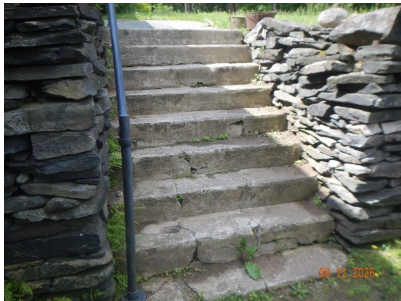
~Front Landscape Stairs and Handrail Replacement: Observation identified that the front concrete landscape stairs are in poor condition with cracking and fractures caused by age and freeze-thaw cycles; The stairs feature inconsistent riser and tread ratios and require full reconstruction to ensure safe footing; Additionally, an approved handrail system must be installed to prevent fall hazards; It is recommended that a qualified contractor reconstruct the concrete stair assembly and install a secure handrail system.

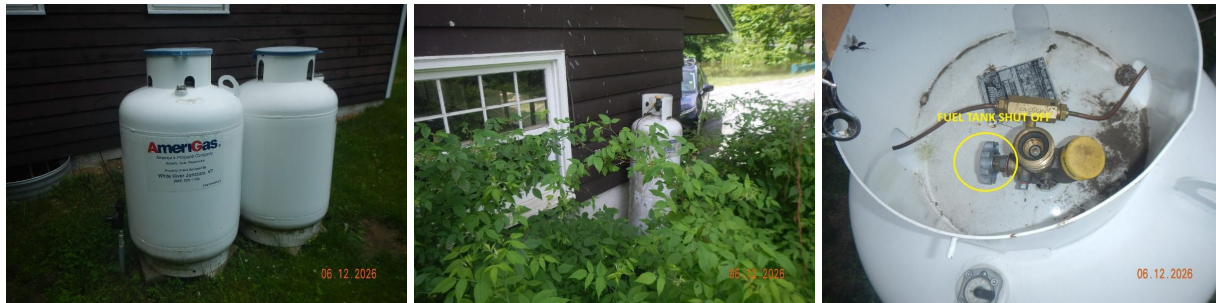
~Propane tanks and their associated delivery systems are considered outside the scope of a standard home inspection; It is recommended that the propane delivery company be contacted prior to the transfer of ownership to confirm the tank's lease or ownership status and to perform a comprehensive safety evaluation; This professional review should verify the condition of the tank, all interior and exterior supply lines, shutoff valves, and regulators; It is essential for the provider to confirm that the regulators have proper venting protection and that the system is appropriately shielded from falling snow or ice; All safety checks and maintenance should be documented by a certified technician in accordance with manufacturer recommendations and state safety standards before taking ownership of the system.

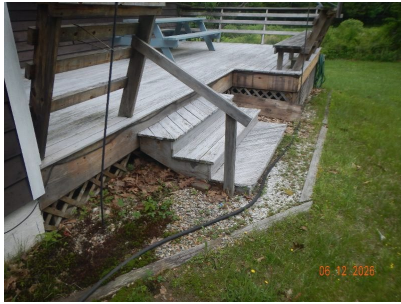
~Deck Stair Handrail Requirement: Observation of the deck stairs identified that the assembly consists of four risers and lacks a properly installed graspable handrail; It is recommended that a qualified building contractor be consulted to install an approved handrail to ensure occupant safety.

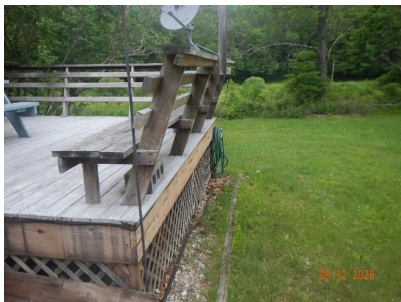
~Deck Structural Attachment Enhancement: Observation of the exterior deck confirmed that newer tie hardware types to the structure are missing; To further improve the connection between the deck and the house, it is recommended that a professional building contractor be consulted to install modern tension-tie hardware or approved deck ledger board screws; This enhancement is important to ensure the deck remains secure and provides long-term stability for occupant safety.

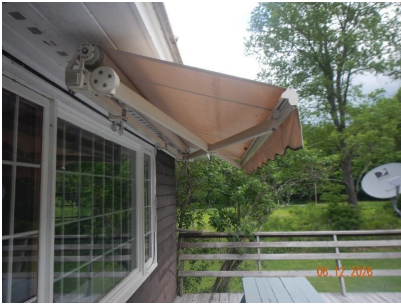
important to have the awning(s) opened fully and verified that the mechanical operation and full covers are in good condition with no damage.

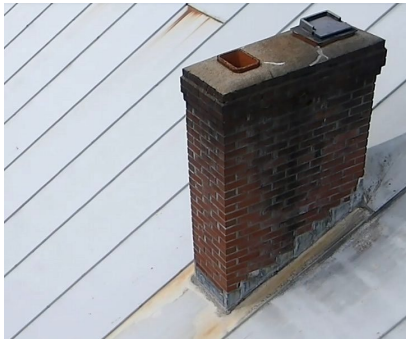
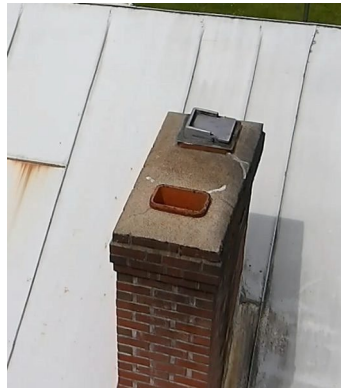
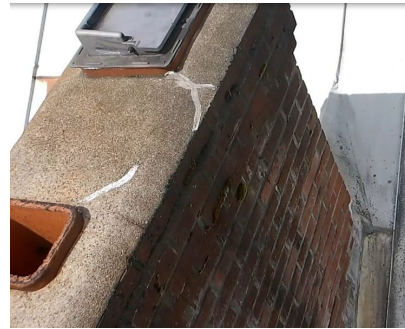
~Chimney and Exterior Masonry Maintenance: Observation of the chimney exterior confirmed that the masonry surfaces and crown require professional attention; It is recommended that a certified chimney sweep or mason be consulted prior to taking possession to perform a full interior and exterior evaluation; This service should include pointing of the mortar joints, cleaning, and waterproofing the brickwork to verify the integrity of the flue liner, flashing, and crown to ensure the system remains safe and watertight.

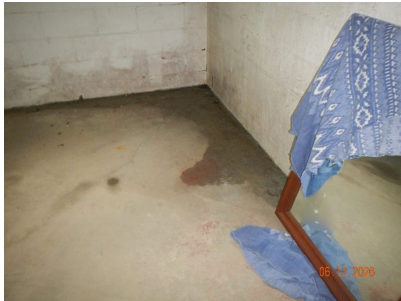
~Garage Corner Moisture and Dampness: Observation identified dampness and moisture accumulation in the corners of the garage structure; It is recommended that a qualified contractor evaluate the area to determine the exact cause of the water intrusion and complete necessary corrections to eliminate the moisture and ensure a dry space.

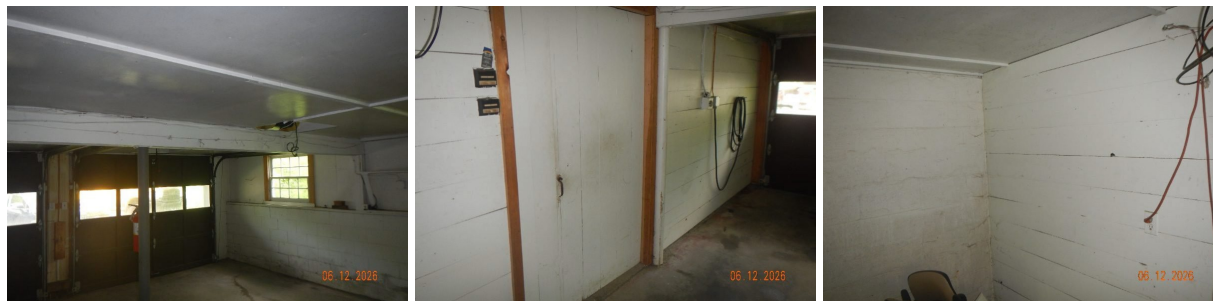
~Garage Fire Separation and Penetrations: Observation of the garage identified that the walls, ceilings, and doors adjoining the living space or attic are not properly sealed for fire protection; All shared surfaces, including access hatches and pull-down stairs, require taped sheetrock or other approved fire separation methods to slow the spread of flames and fumes; In addition, any penetrations such as ductwork, electrical lines, or pipes must be properly fire-stopped and approved fire doors fully trimmed; It is recommended that a qualified building contractor be consulted to install the correct materials and thickness conforming to all safety building construction requirements.

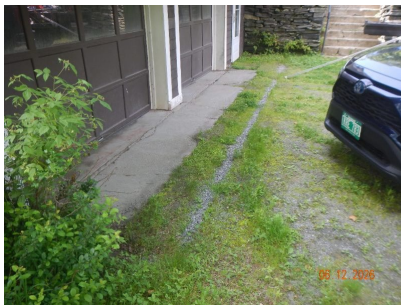
~Garage Door Apron Maintenance: Observation of the garage noted that the concrete apron is in decline due to age and frost damage; It is recommended that a qualified concrete contractor be consulted to explore methods for repair or replacement; Completing these repairs is important to eliminate the deteriorating condition and ensure a smooth, stable transition at the garage entrance.

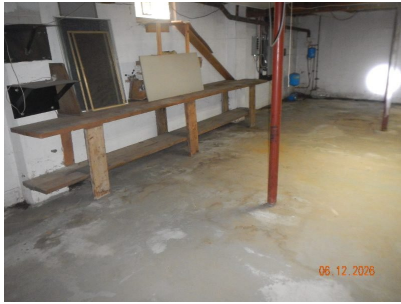
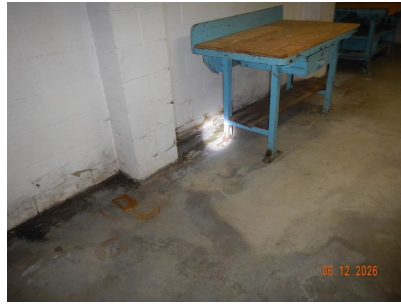
~Basement Moisture And Dampness: Observation of the basement measured a relative humidity level of 64%, which exceeds the ideal range of 45% to 50%; Damp areas in corners and along the front wall with evidence of past staining and efflorescence on the wall and floor surfaces in other parts of the basement; It is recommended that a professional basement water specialist be consulted to determine and correct the cause of the moisture and to prevent future entry; Once these repairs are made, the use of an installed dehumidification system is important to manage humidity and improve air quality.

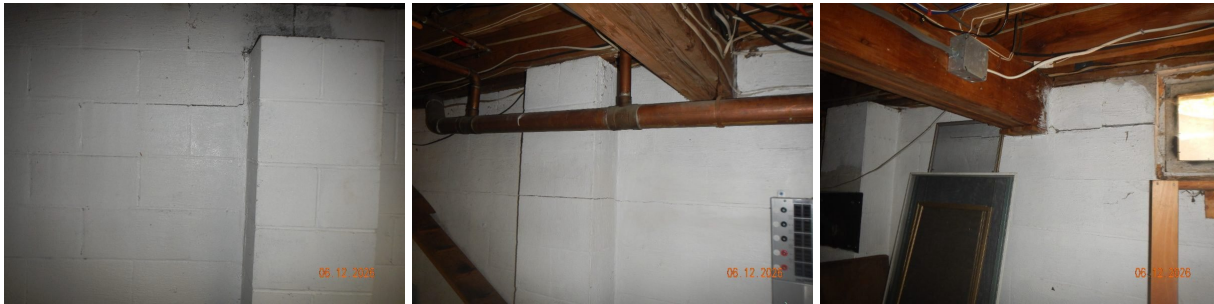
~Cinder Block Wall Mortar Joint Separations: Observation identified separations and cracking in some of the mortar joints on the cinder block walls due to age and settling over time; It is recommended that a qualified masonry contractor point and fill the joints to ensure the strength of the foundation.

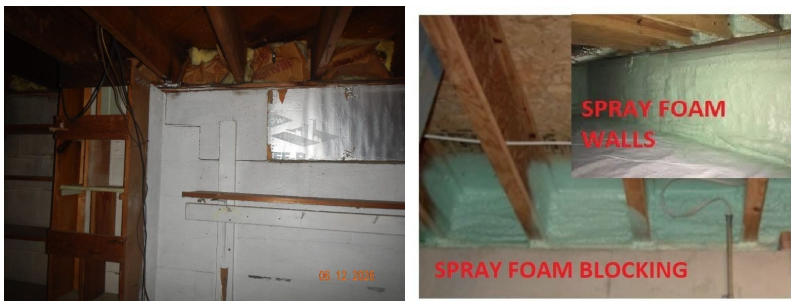
~Basement Insulation and Blocking Methods: Observation of the basement area noted that modern energy efficiency improvements often involve the installation of spray foam or non-papered fiberglass insulation between the first floor and the top of the foundation; In some instances, these materials are applied to all interior basement walls and wood blocking within crawlspaces to enhance thermal performance; It is recommended that a professional insulating contractor be consulted to discuss the various options and ensure that any current or future installations meet specific ventilation and fire-safety standards.

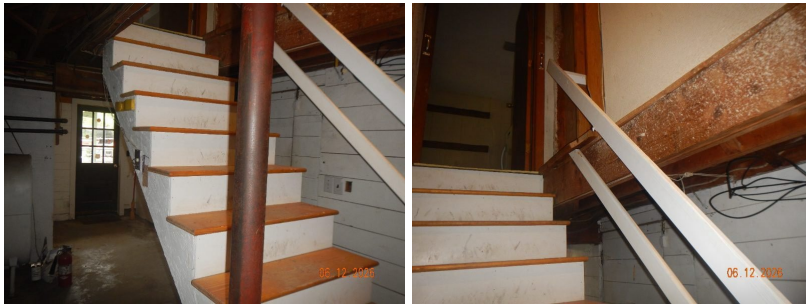
~Basement Stairway Guardrail Requirements: Observation of the basement staircase identified that the stairs lack protective guardrails along the open-sided portions and landings; Modern safety protocols advise that guardrails be provided for any elevated transition where a fall hazard exists; It is recommended that a qualified contractor be consulted to install a code-compliant guardrail system with balusters spaced no more than a four inch sphere passing through.

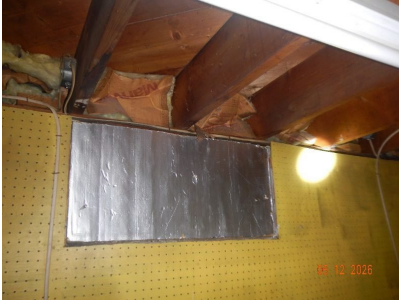
~Blocked Basement Windows: Assessment identified that some basement windows have been covered and sealed with insulation board, preventing access; It is recommended that the insulation boards be removed so the windows can be fully assessed to determine their operational condition, and that any necessary repairs or replacements be completed.

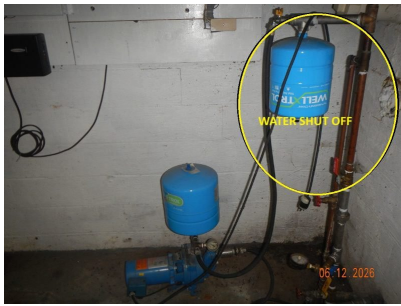
~Secondary Water Line and Booster Pump: Assessment identified a secondary water line and a booster pump assembly that was unplugged and non-operational at the time of inspection; The exact function, water source, and termination points or connected appliances of this system are unknown; It is recommended that a qualified well service contractor evaluate the entire assembly to determine its purpose and operational condition.

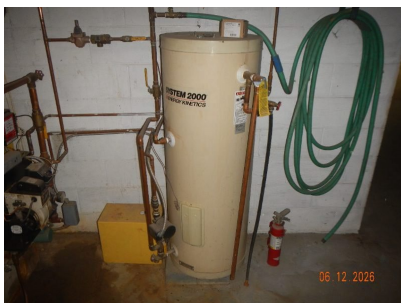
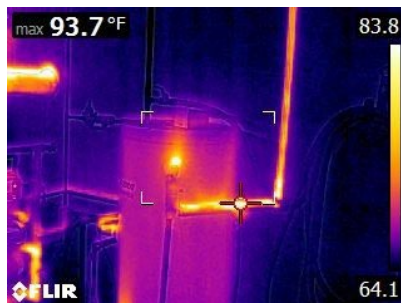
~Missing Thermal Mixing Valve: Observation of the water heater identified that a thermal mixing valve is not installed; While requirements for these valves vary by state, they are a recommended safety feature to prevent accidental scalding by mixing cold water with the hot water leaving the tank; It is suggested that a licensed plumber be consulted to install a mixing valve to ensure safe and consistent water temperatures throughout the home.

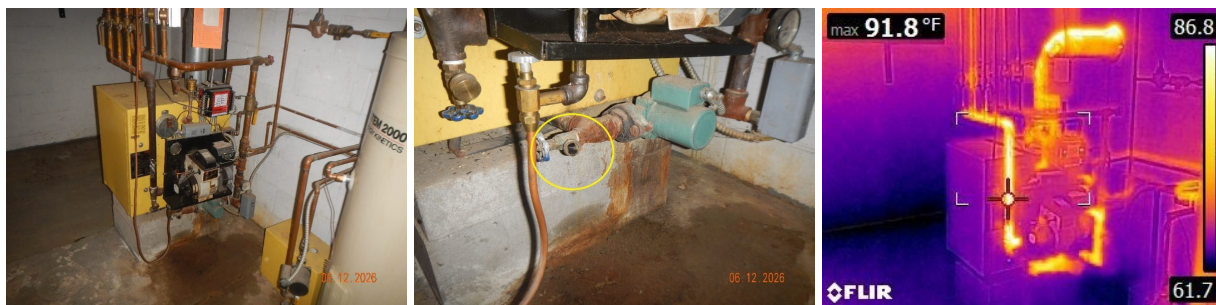
~The cause of the seepage at the drain valve at the base of the boiler will need to be determined and corrected at the boilers service.

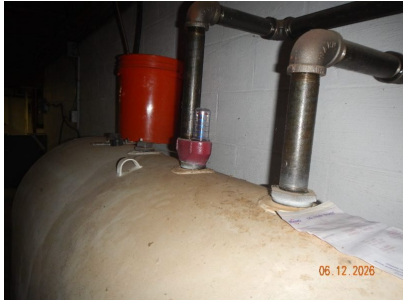
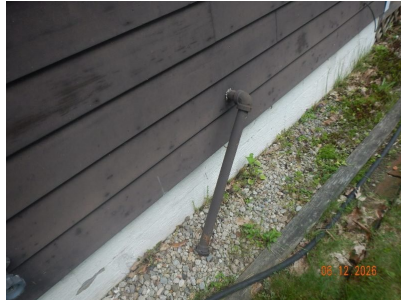
~A tipped oil tank venting line was observed at the rear of the home; The lines function will need to be determined and the line removed.

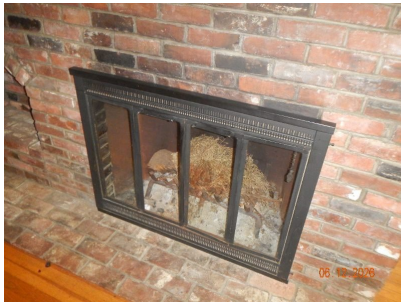
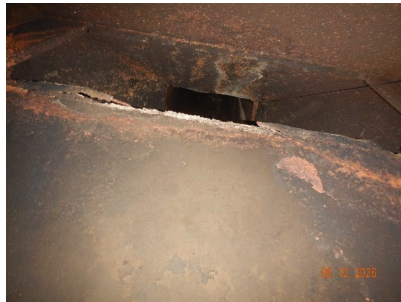
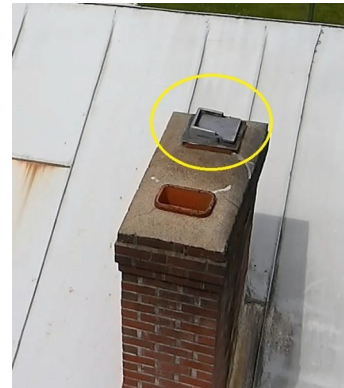
~The chimney top damper chain was not located; The chain will need to be confirmed at the chimney service.

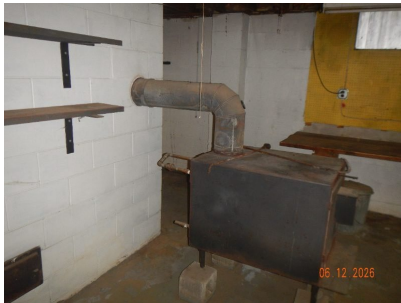
~2026/27 Heating Season: If not completed this year, all woodstoves in the home will require cleaning, inspecting, and any safety deficiencies corrected before use by a professional chimney service/Chimney Sweep and ongoing on a yearly basis to ensure the stove and chimney are safe and function properly.

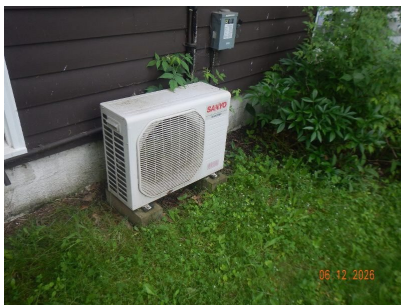
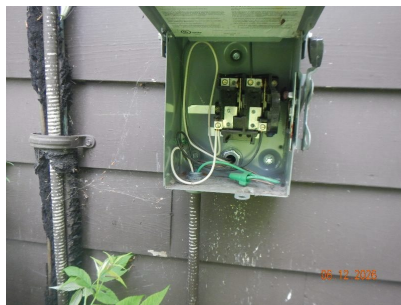
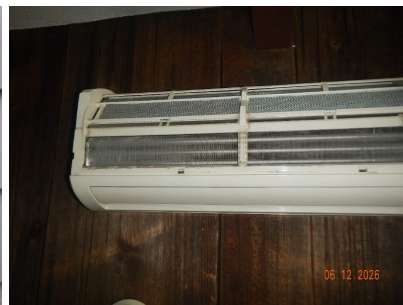
~Ductless Mini-Split Deficiencies: Assessment identified that the ductless mini-split air conditioning system is non-operational and features multiple exterior and interior deficiencies; The remote control was not located, the exterior refrigerant line sets are missing required insulation and the vegetation around the unit needs to be removed; On the interior wall head unit, dust and dirt accumulation along with a damaged cover housing were observed; It is recommended that a licensed HVAC contractor fully evaluate and service the installation to clean components, replace missing insulation, and determine if the unit can be repaired or requires replacement.

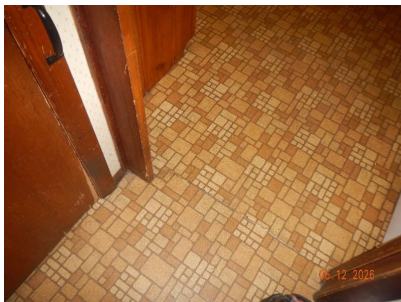
~Kitchen-to-Laundry Threshold Settling and Crack: Evaluation revealed evidence of a settlement crack at the threshold between the kitchen and laundry room, which has caused the flooring in that area to crack; It is recommended that a qualified contractor determine and correct the underlying cause of the settling before new flooring material is installed.

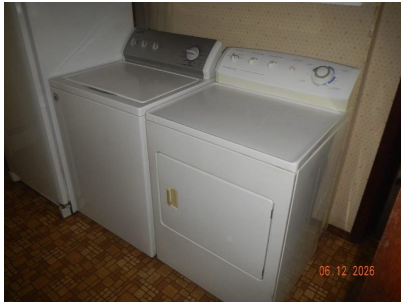
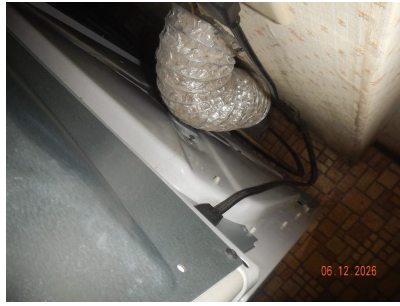
**-Important Fire Protection Maintenance: At Move In And Ongoing:** Washer and Dryer Behind and Under Unit Clean-up: An important maintenance task for fire prevention, the areas behind the washer and dryer cleaned and vacuumed of all lint, dust and objects that find their way behind the units over time; The dryer vent and all connecting venting hoses should be cleaned and if plastic vent pipes discovered replaced with metal and the termination point outside the home confirmed; The clothing washing machine plumbing and drain connections should be reviewed for proper installation and shut off ability; The clothing washing machine is not tested as part of the inspection due to the possibility of leaving water in the unit; Verification of the units operability should be made with the seller if the unit is part of the sale.

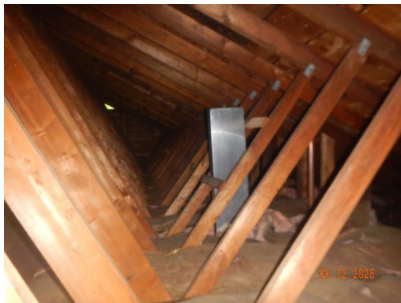
~Kitchen Vent Ductwork Terminated in Attic: Evaluation revealed that the kitchen exhaust vent ductwork terminates directly inside the attic space rather than extending to the building exterior; This improper termination creates a fire risk and introduces moisture into the attic; It is recommended that a qualified contractor properly route and construct the ductwork to the exterior of the home in accordance with current building standards and approved material type.

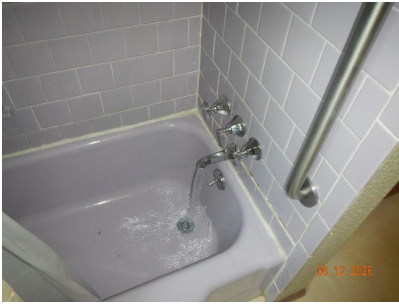
~Loose Tile and Moisture Damage: Evaluation revealed loose tiles, damaged wall surfaces, and heavy caulking, indicating moisture penetration behind the tile assembly; It is recommended that a qualified contractor remove the affected tile, repair all hidden wall damage, and reinstall a properly sealed wall finish.

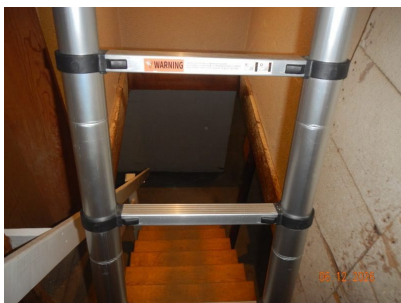
~Attic Access Location Deficiencies (Basement Stairwell): Assessment identified that the attic scuttle hole is located directly above the basement stairwell opening; Due to the severe fall hazard of climbing into and out of this opening over an open stairwell, the attic inspection was performed from a limited ladder position using a strong flashlight to view the space; Visible areas indicated satisfactory conditions except where noted; It is recommended that a qualified contractor seal this scuttle hole and relocate the attic access hatch to a safer, level space in the home, such as a hallway or closet ceiling, allowing for a full inspection of the attic space.

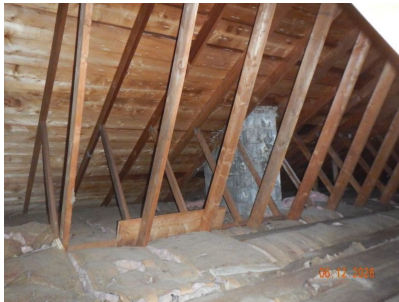
~Attic Ventilation: Observation of the attic space confirmed that the existing soffit vents are blocked or improperly installed; To provide the best venting condition, the installation of attic soffit baffles and properly sized gable end venting or an alternative method is recommended to allow heat to move effectively out of the space during summer months and moisture in the winter; It is suggested that a professional insulation and venting company be consulted to correct the airflow and ensure the attic remains dry and well-ventilated.

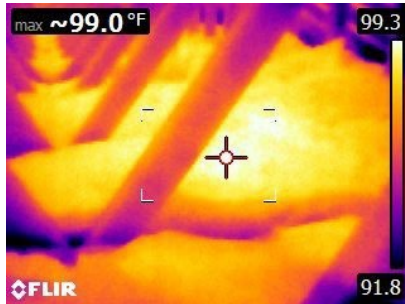
~Existing Insulation Removal and Preparation: Notice of the attic cavity identified that a complete removal of existing insulation, including vacuuming of the space, is the most effective preparation for an upgrade; This method allows for the removal of dated or pest-damaged material and provides clear access for a full electrical inspection; It is recommended that you contact your local electric utility provider for guidance on qualified contractors and potential rebates available for comprehensive air sealing and insulation removal.

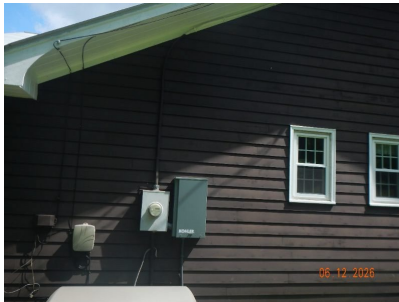
~Improperly Terminated Wires At Service Location: Assessment identified improperly terminated electrical wires at the exterior service meter location; Unprotected wires pose an electrical shock and fire hazard; It is recommended that a licensed electrician evaluate the installation to properly terminate the wires inside an approved exterior junction box or remove the abandoned conductors entirely.

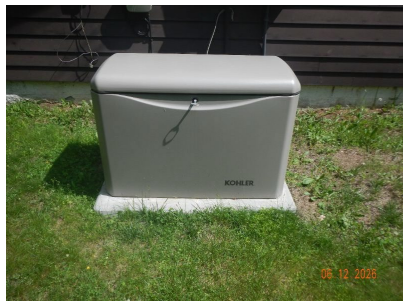
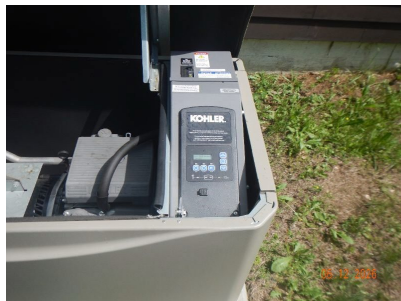
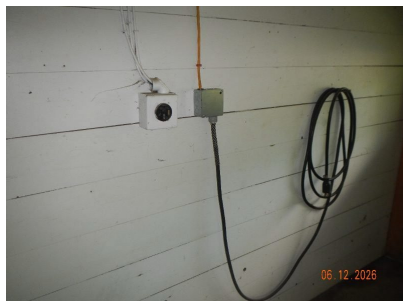
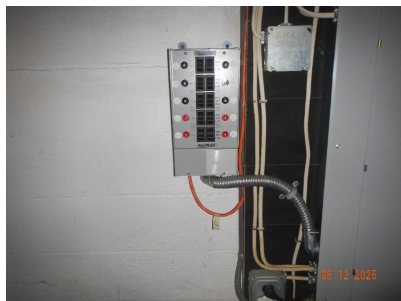
~Second Source Portable Generator and Manual Transfer Switch: The home is equipped with a portable generator and manual transfer switch at the electrical panel; The switch is not tested as part of the home inspection scope; A licensed electrician should be consulted about the removal of the second source.

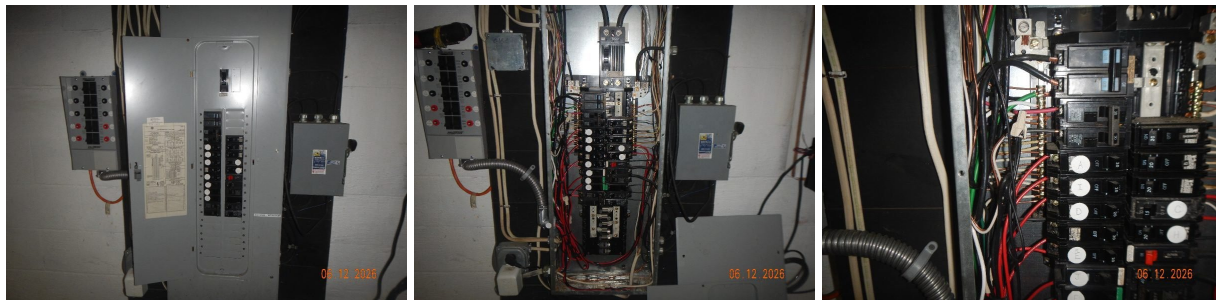
~Sub-Panel Wiring Designation: This entry refers to the main electrical panel, which requires rewiring to meet sub-panel configuration standards; Because the primary service disconnect is located at the exterior meter, the interior panel must be isolated according to sub-panel rules; The specific requirements for separating the neutral and ground conductors must be determined and corrected by a licensed electrical contractor to ensure the system is safe and code-compliant.

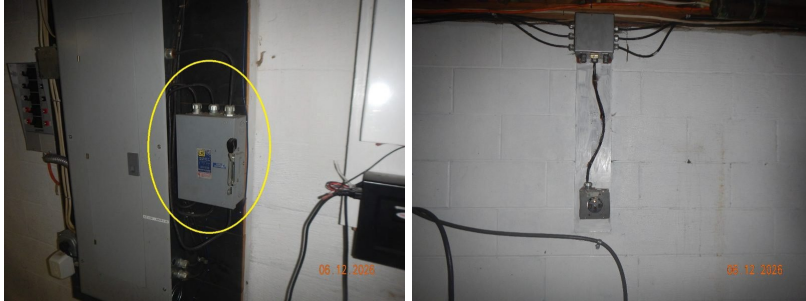
~Subpanel and Unprotected Cable Deficiencies: Assessment identified unprotected non-metallic sheathed cable ("builder's wire") routed to a 240-volt outlet in the basement; Exposed electrical cables are subject to physical impact and require mechanical protection; Additionally, this basement outlet requires ground-fault circuit-interrupter (GFCI) protection for safety; It is recommended that a licensed electrician perform a full review of the subpanel wiring, circuit dedication, install proper GFCI protection, and secure all exposed cables within an approved conduit sleeve.

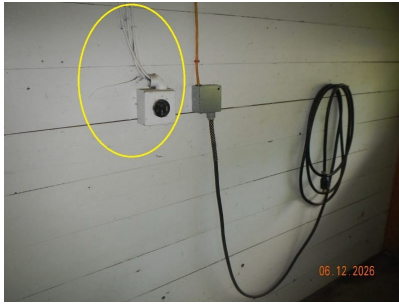
~240 Volt GFCI Protection And Builders Wire: Not Installed: GFCI electrically protected 240 Volt receptacles are required in the garage and all exposed conductors installed in conduit and properly connected to the outlet.
