# River Valley Home Inspections LLC

David M. DeSimone  
ID: Board Certified and Licensed in NH and VT  
244 Town Shed Road  
Orford, NH 03777

## Summary

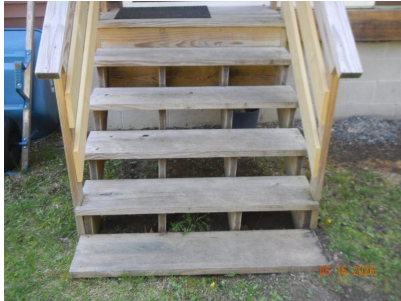
~Stairway Handrail Configuration: Examination of the currently installed step rail system noted that it lacks a graspable profile; Modern guidelines advise that a graspable surface provides a more secure grip to aid in user stability; It is recommended that a qualified contractor be consulted to evaluate the installation of a graspable handrail.

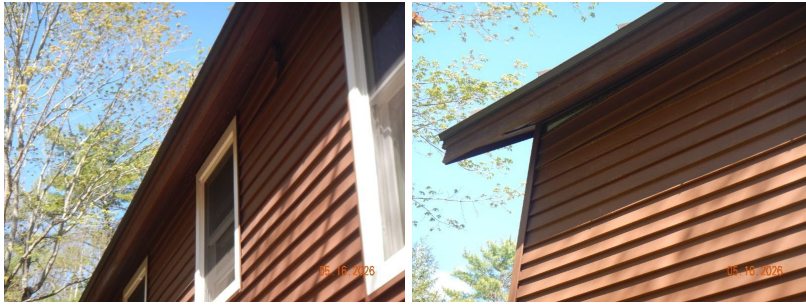
Front Of Home.

~Loose Vinyl Siding and Pest Exposure: Observation of the exterior identified loose pieces of vinyl siding; It is advised that this section be properly secured to prevent wind damage and eliminate potential pest entry points; Fixing the siding promptly is important to protect the underlying wall sheathing from weather exposure and pest impacts.

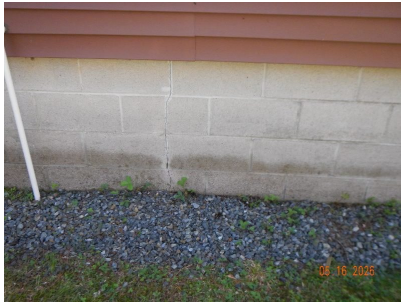
Rear Of Home.

~Foundation Crack Maintenance: 1/4 Inch Or Less: Observation of the foundation walls identified several cracks measuring 1/4 inch or less; While these fractures do not currently appear to be structurally significant, they can allow moisture or pests to enter the home over time; It is recommended that a qualified contractor be consulted to review and professionally seal these cracks; This maintenance step is important to prevent water incursion and to protect the long-term integrity of the foundation.

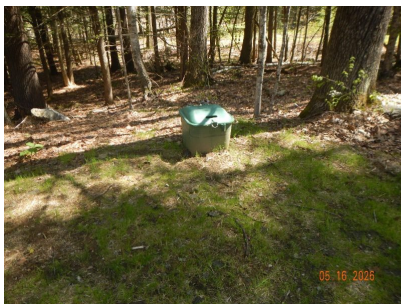
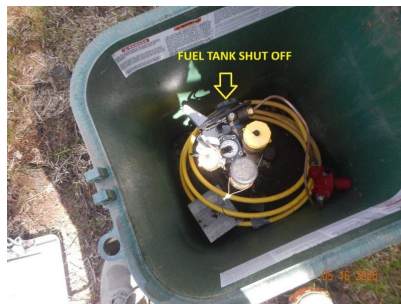
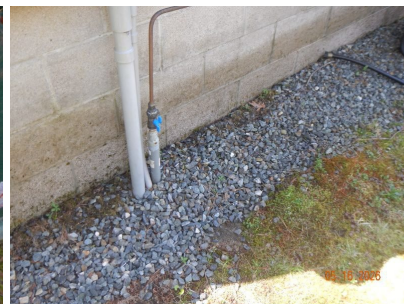
~Propane tanks and their associated delivery systems are considered outside the scope of a standard home inspection; It is recommended that the propane delivery company be contacted prior to the transfer of ownership to confirm the tank's lease or ownership status and to perform a comprehensive safety evaluation; This professional review should verify the condition of the tank, all interior and exterior supply lines, shutoff valves, and regulators; It is essential for the provider to confirm that the regulators have proper venting protection and that the system is appropriately shielded from falling snow or ice; All safety checks and maintenance should be documented by a certified technician in accordance with manufacturer recommendations and state safety standards before taking ownership of the system.

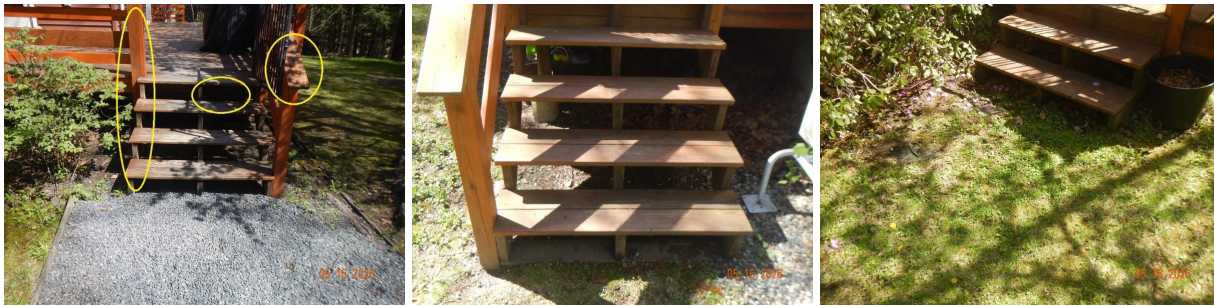
~Open Stair Riser Safety: Assessment of the deck stairs identified "open risers," where the vertical space between steps is open; Modern safety standards require these gaps to be small enough so a 4-inch ball cannot pass through; It is recommended that a qualified building contractor be consulted to install riser enclosures to meet current safety requirements.

~Stairway Landing Pad: Evaluation of the staircase noted that the last step terminates onto a surface lacking a proper landing pad; It is recommended that a qualified building contractor be consulted to install a level, stable landing at the base of the stairs to ensure a uniform and safe transition when stepping off the final riser.

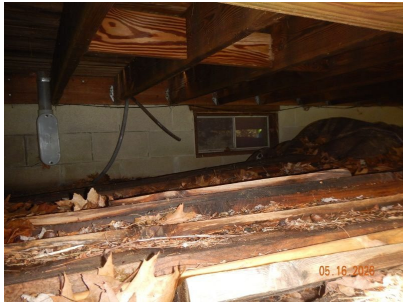
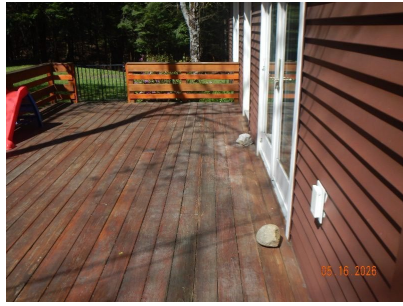
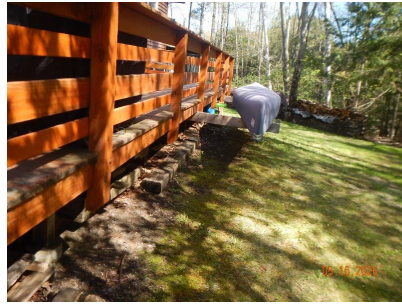
~Deck Surface Grating Options: Observation of the deck identified that adding a section of open steel or composite grating where the deck meets the home would be beneficial; Implementing this grating allows snow and water to pass through freely, rather than piling up against the structure; It is advised that a qualified deck contractor explore options for this addition to reduce seasonal moisture impacts along the home's siding and door openings.

~Notched Guardrail Posts: Observation of the deck noted that the guardrail posts have been notched at the point of attachment; It is advised that a qualified contractor reinforce or replace the posts to ensure the railing system is safe and secure.

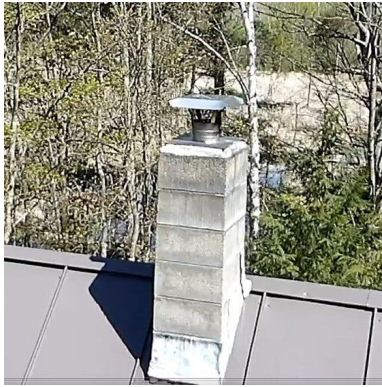
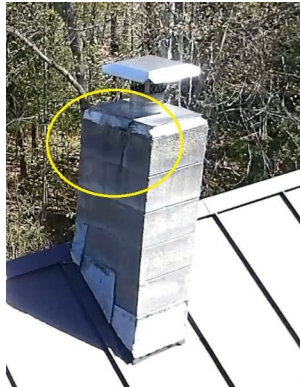
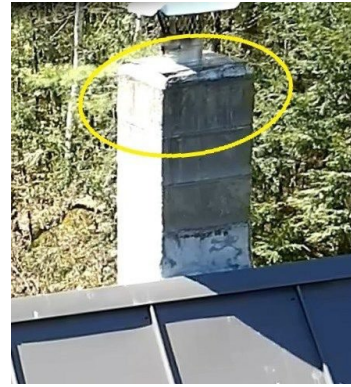
~Concrete Block Chimney Evaluation: Observation of the concrete block chimney confirmed it is in generally good condition with chimney crown maintenance needed; It is recommended that a certified Chimney Sweep be consulted to perform a full interior cleaning; Additionally, the exterior crown will need to

be repaired and the chimney cleaned and a waterproof sealant applied to protect the block; This professional maintenance is important to ensure the chimney remains safe and weather-tight.

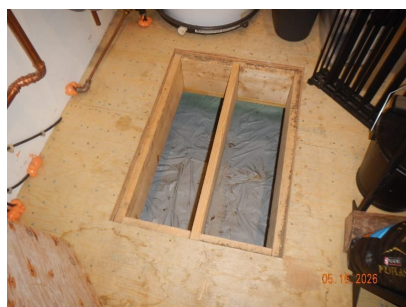
~Crawlspace Access Modification: Observation of the crawlspace access identified that a floor joist blocks the opening and restricts entry; It is advised that a qualified building contractor reframe the opening to clear the obstruction; Modifying the frame is important to allow for easy access while keeping the surrounding floor properly supported

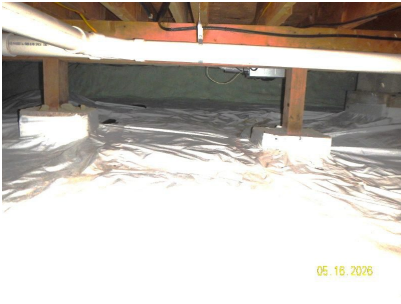
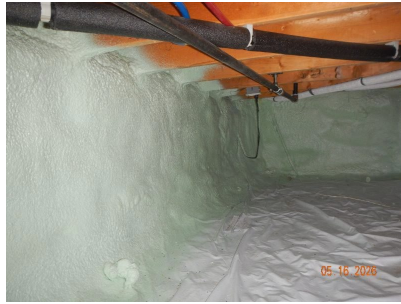
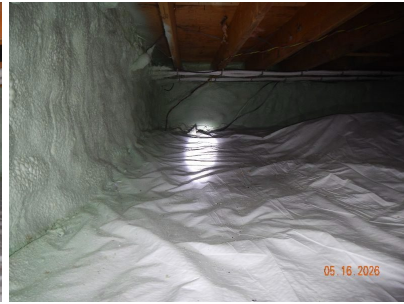
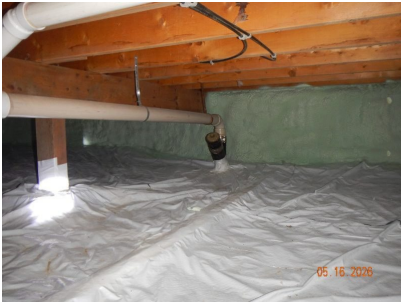
~Insulated Basement Inspection Limitations: This observation indicates that because of the installed insulation, the main structural beams, floor joists, sub-flooring, and foundation sills were not fully visible for inspection; Consequently, the structural condition of these concealed components is unknown; The limited areas that remained exposed and accessible were found to be in satisfactory condition at the time of the inspection.

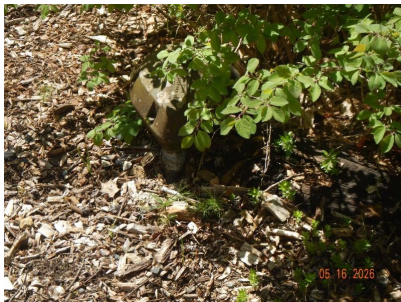
~Drilled Well Head Maintenance: Observation of the drilled well head identified a need for general maintenance around the perimeter; It is advised that vegetation and debris be cleared, the soil graded to slope away from the casing, and a gravel base installed; Performing this landscaping upkeep is important to ensure surface water drains away from the well head.

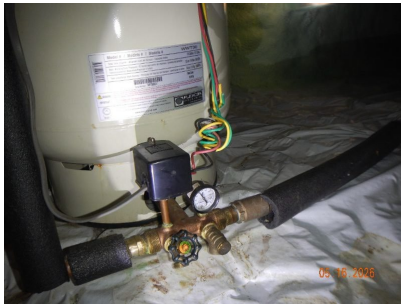
~Well: Catch-pan: If not completed, all dirt and debris and any nonessential items should be removed from around the homes water system; Condensation generated from cold water pipes and humid room conditions, common in this area, drip onto floors and drop ceilings if installed; Adding a drip catch pan below the well pump pressure gauge and piping area at the base of the tank will help lessen this impact.

~Crawlspace Water Shutoff Accessibility: Observation of the main water shutoff confirmed that a single shutoff valve was not located in close proximity the pressure tank; It is recommended that a shutoff be installed in a more accessible area or that a smart home electronic solenoid and leak detection system be installed for remote operation.

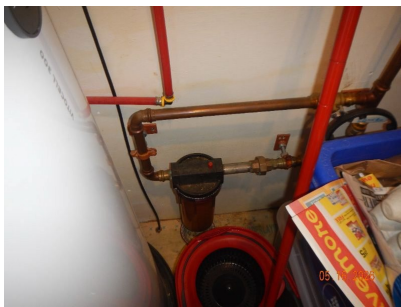
~Canister Filter: The filter cartridge will need to be changed per manufacturers recommended intervals; If a red or sometimes blue button is present on the top of the filter housing, the button will need to be pressed after closing the water supply to the filter to release pressure.

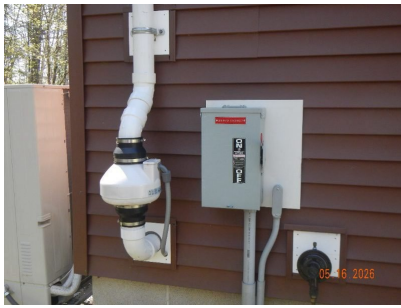
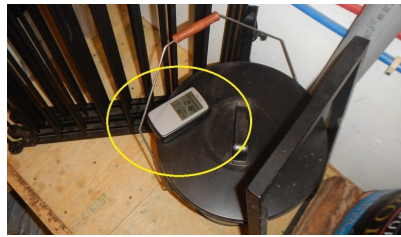
~The home is equipped with a Radon air reduction system; The fan is running; It is recommended the use

of the continuous Radon monitoring unit be continued and lab testing be performed to ensure the system is reducing Radon to safe levels and operating as designed.

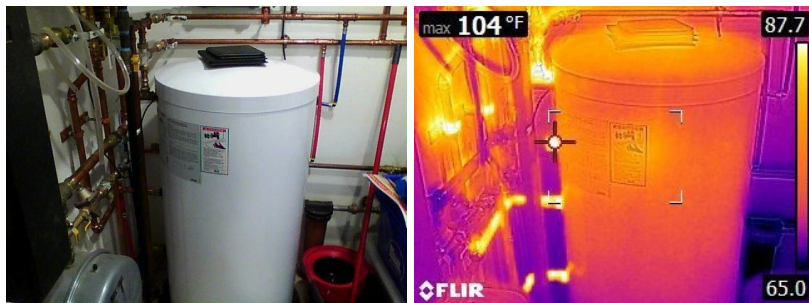
~Over time, mineral sediment from the water supply settles at the bottom of the tank; This buildup forces the heating elements to work harder, which reduces efficiency and can cause premature failure; for optimal performance and to prolong the life of the water heater, it is recommended that the tank be flushed annually to remove accumulated sediment; This maintenance task should be performed by a qualified licensed plumbing contractor.

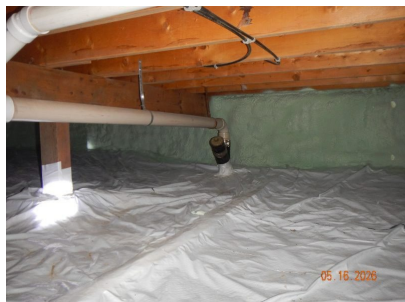
~Private Septic System Evaluation: This observation indicates that at the time of the inspection, the interior portions of the septic system are functioning with adequate drain flow and no unusual septic odors within the home; However, a comprehensive evaluation of the exterior components is outside the scope of this inspection; A licensed septic professional must be consulted to verify the integrity and functionality of the septic tank, the distribution box, and the leach field; This assessment should include an inspection of the piping and a review of the tank's current condition and pumping history before taking possession of the home.

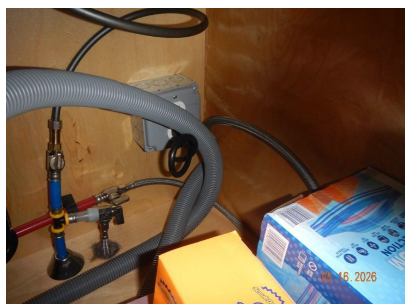
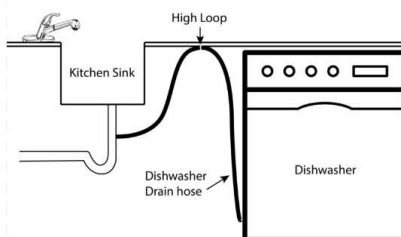
~The dishwasher drain line lacks required backflow prevention, such as an approved air gap device or a secured high drain loop under the kitchen sink countertop; This condition can allow contaminated water to back up into the unit; Correction by a qualified plumber is recommended to ensure the dishwasher drains properly.

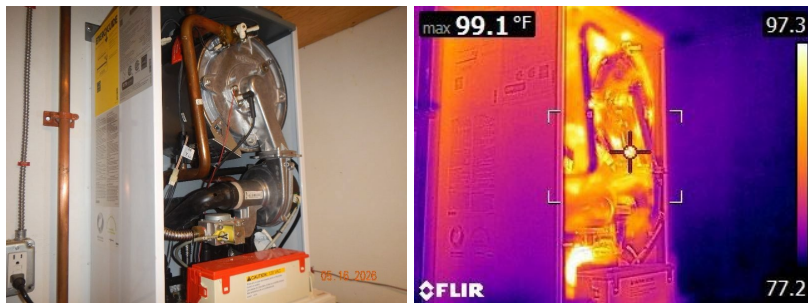
~Propane Boiler Service and Maintenance: Observation of the propane boiler noted that the last service date could not be determined; To establish a baseline operating condition before taking possession, it is recommended that a licensed heating contractor perform a full service and cleaning; This should include an inspection of the shroud, sensors, piping, and circulation pumps for proper operation, corrosion, or scale; Annual servicing and the use of available service plans is important for propane-fired boilers to ensure all mechanical and exhaust components remain in safe and satisfactory condition.

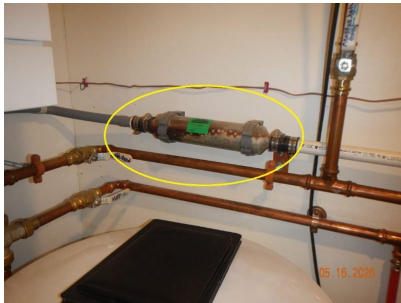
~Test and Recharge At Service: The condensate produced by the boiler is acidic and has the potential to harm the environment and the sewer/septic system; The water discharge should be tested annually and the capsule recharged per manufacturers recommended procedures on a yearly basis when the boiler is serviced.

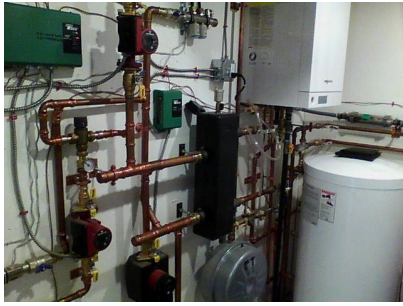
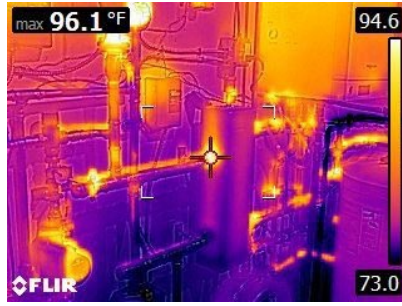
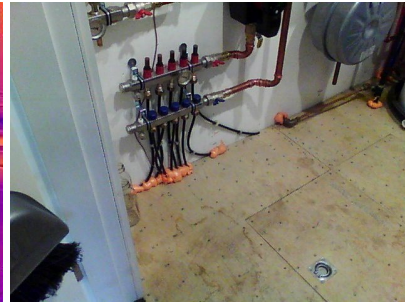
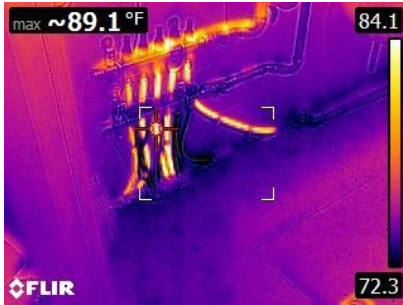
~Radiant Floor Heating Weather Inspection Limitation: Observation of the heating system identified that the radiant floors could not be fully tested due to warmer weather conditions and the longer lead time required for these systems to fully heat up; While the circulation pumps and utility room piping indicate the system is operational, full heating performance cannot be confirmed until it is run in colder weather; It is advised that a qualified HVAC technician perform a baseline service before the winter season to ensure all zones heat properly.

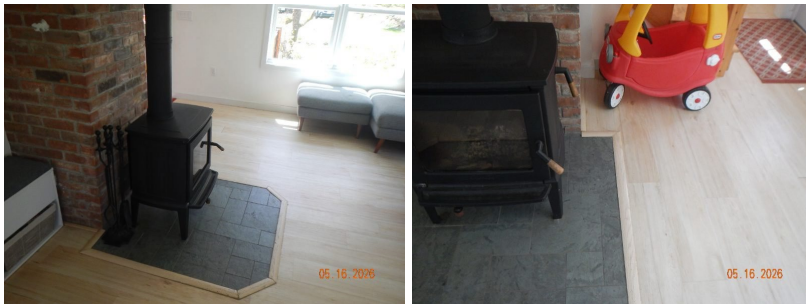
~2026/27 Heating Season: If not completed this year, all woodstoves in the home will require cleaning, inspecting, and any safety deficiencies corrected before use by a professional chimney service/Chimney Sweep and ongoing on a yearly basis to ensure the stove and chimney are safe and function properly.

~Wood Stove Hearth Clearance: Evaluation of the heating area revealed that the current hearth does not provide the required 18 inches of clearance from combustible floor surfaces; wood-burning appliances require this specific buffer to protect against heat radiation and stray embers; the hearth will require the installation of additional non-combustible floor protection to meet safety standards; all modifications should be completed in accordance with manufacturer recommendations and local fire codes to ensure the safety of the residence.

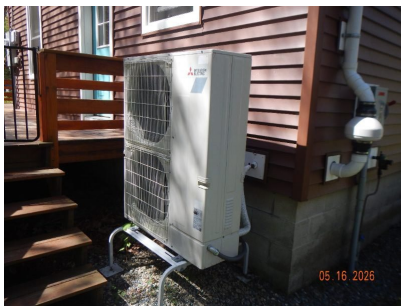
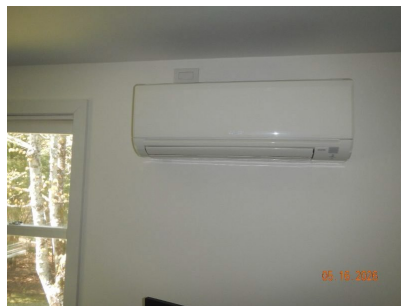
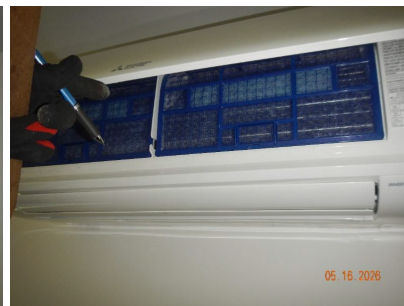
~Heat Pump System Comprehensive Service: Observation of the property identified an installed heat pump system; It is advised that a qualified HVAC professional perform a review of both the interior air handling unit and the exterior condenser unit; This service should include cleaning or replacing all filters, clearing the exterior coils of debris, and verifying proper system operation; Regular professional maintenance is important for a buyer to maintain indoor air quality, maximize energy efficiency, and protect the longevity of the heating and cooling system.

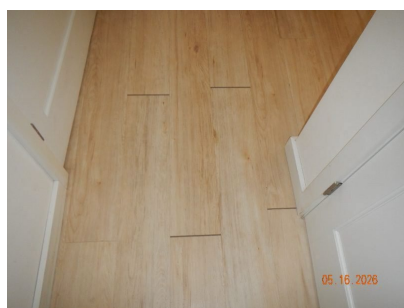
~Laminate Floor Gaps: Observation of the flooring identified gaps between some of the planks; It is advised that a qualified flooring contractor review the installation to determine the cause and perform any necessary repairs; Correcting these gaps is important to ensure the floor remains secure and easy to clean.

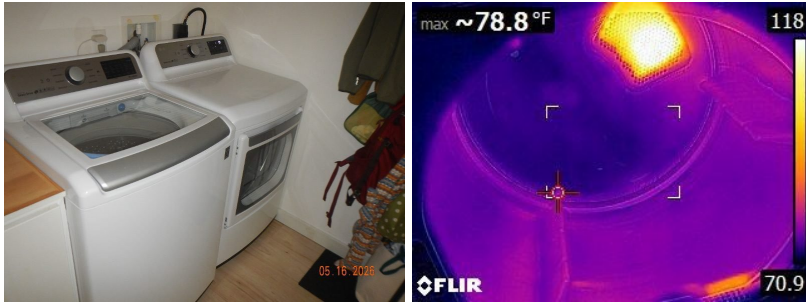
~Important Fire Protection Maintenance: At Move In And Ongoing: Washer and Dryer Behind and Under Unit Clean-up: An important maintenance task for fire prevention, the areas behind the washer and dryer cleaned and vacuumed of all lint, dust and objects that find their way behind the units over time; The dryer vent and all connecting venting hoses should be cleaned and if plastic vent pipes discovered replaced with metal and the termination point outside the home confirmed; The clothing washing machine plumbing and drain connections should be reviewed for proper installation and shut off ability; The clothing washing machine is not tested as part of the inspection due to the possibility of leaving water in the unit; Verification of the units operability should be made with the seller if the unit is part of the sale.

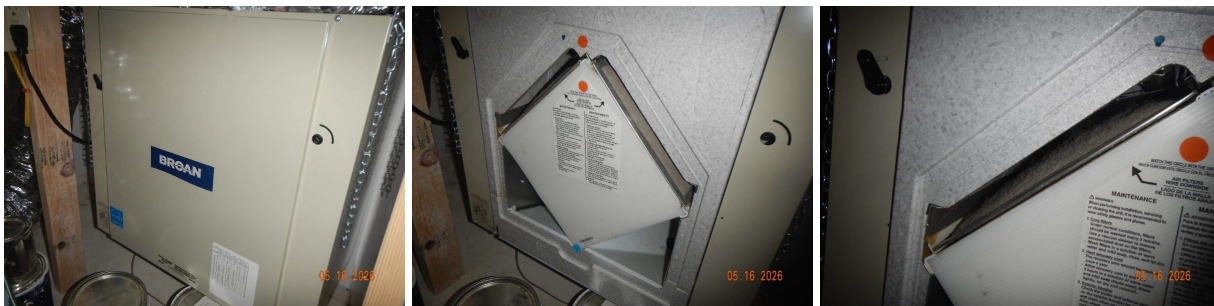
~Energy Recovery Ventilator (ERV) Maintenance: Observation of the home identified an Energy Recovery Ventilator (ERV) system; These units improve air quality by exchanging indoor and outdoor air while filtering impurities; It is recommended that the unit be inspected and maintained according to the manufacturer's instructions, including washing filters, vacuuming the interior, and cleaning exterior vents to ensure optimal performance.

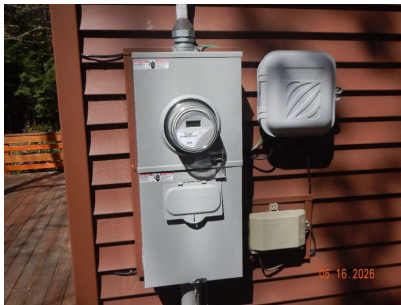
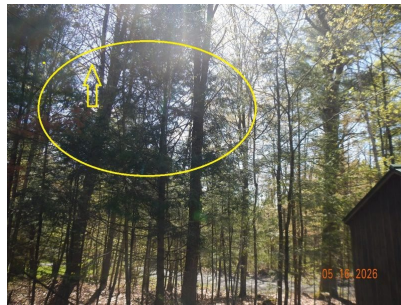
~Electrical Service Tree Trimming: Observation of the exterior electrical service identified that tree limbs are growing close to or are in direct contact with the overhead service lines; This contact can cause power interruptions or damage to the home's electrical system during limb failure events or windy conditions; It is recommended that the local utility provider be contacted to safely trim the branches away from the wires; Do not perform this work on your own as service lines can cause serious injuries or death.

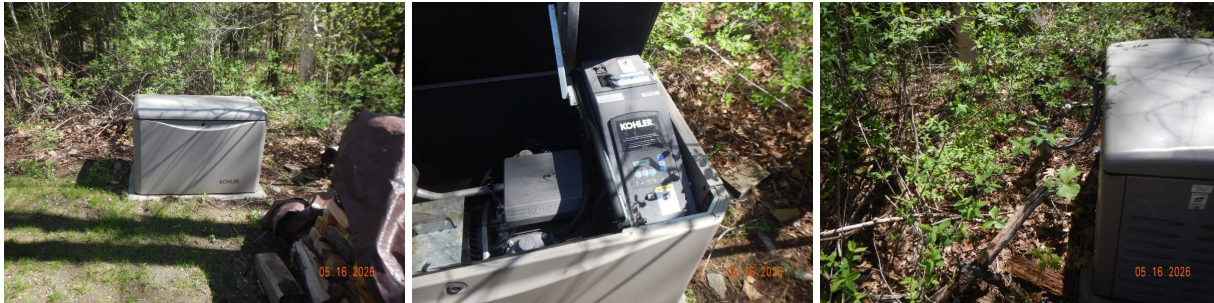
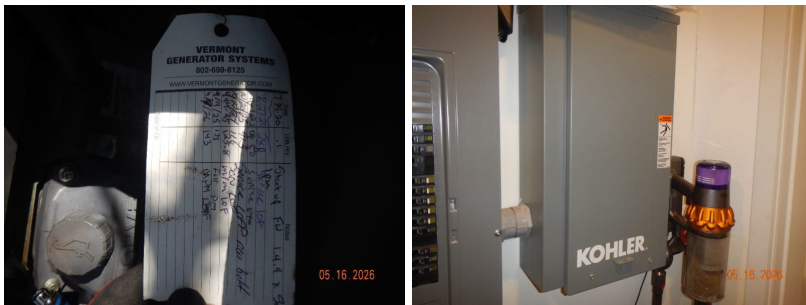
~Clear Vegetation: All vegetation around the unit needs to be cleared to allow for full airflow into the unit when in operation.

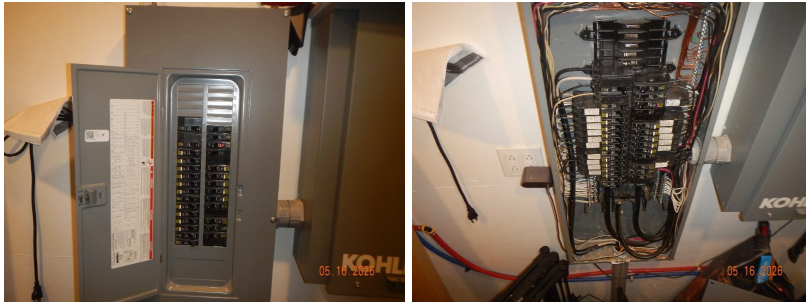
~Circuit Labeling and Verification: It is recommended that the labeling be professionally updated to accurately reflect the current use of all areas in the home; Proper labeling is essential for safety during maintenance and in the event of an emergency.

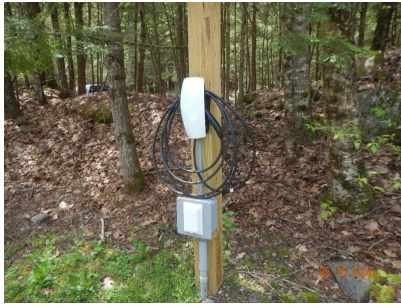
~Exterior EV Car Charger Safety: Observation of the property identified an exterior electric vehicle (EV) car charger; It is necessary that the 240-volt (commonly referred to as 220V) electrical circuit feeding the charger be confirmed as GFCI protected; Ensuring ground-fault protection is important for an outdoor charging station to prevent shock hazards and to meet safe building standards for damp or wet environments.

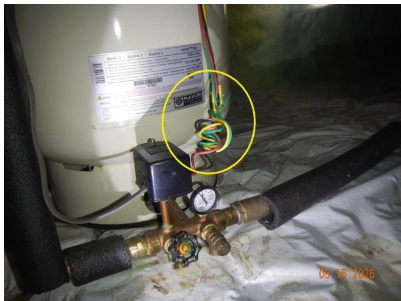
~Well Pump Electrical Grounding Deficiency: Observation of the well system identified an older two-wire power supply that lacks a safety grounding wire; It is advised that a licensed electrician review the system to upgrade the circuit to include a proper ground path; Correcting this missing ground is important to eliminate shock hazards and ensure the circuit breaker trips safely during an electrical fault.
