# River Valley Home Inspections LLC

David M. DeSimone  
ID: Board Certified and Licensed in NH and VT  
244 Town Shed Road  
Orford, NH 03777

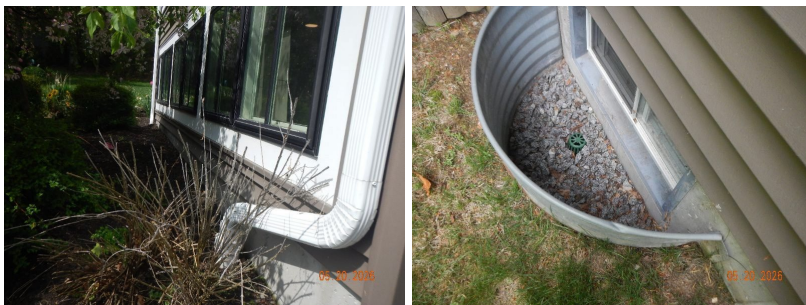
~Exterior Drainage System Maintenance: Observation of the exterior identified connected gutters and window well drain covers that form the home's drainage system; It is advised to locate, mark, and clean all openings to prevent water from backing up along the foundation; It is necessary to add the system's exit point locations to the Home Information File; Keeping these lines clear is important to protect the foundation from water damage.

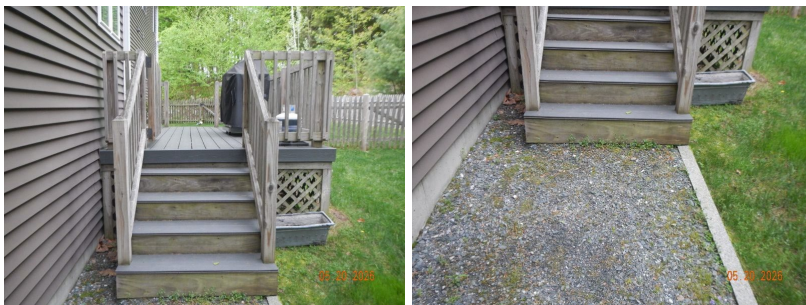
~Exterior Deck Stairway Handrail: Modern safety standards require an approved "graspable" handrail that a person can easily wrap their hand around for stability; It is recommended that a qualified contractor be consulted to replace or modify the current railing with one that meets current safety rules; This safety update is important for the secure use of the stairs.

~Tall Last Step And Stairway Landing Pad: Evaluation of the staircase noted that the last step terminates onto a surface lacking a proper landing pad; It is recommended that a qualified building contractor be consulted to install a level, stable landing at the base of the stairs to ensure a uniform and safe transition when stepping off the final riser.

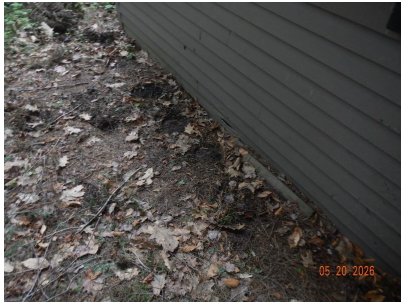
~Shed Grading Correction: Observation of the shed identified improper grading that allows water to pool near the structure; It is advised to regrade the soil to slope away from the foundation at a pitch of 5/8 inch per foot; Installing a stone border over a vapor barrier is recommended to prevent soil splashing onto the siding; The top of the stone border should remain at least 6 inches below the siding edge to protect the wooden sills from moisture rot.

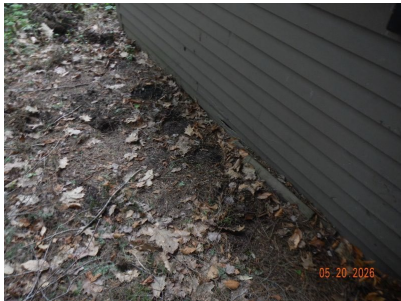
~Shed Siding Decay: Observation of the shed identified siding decay caused by long-term moisture and snow contact; It is advised to perform a full review, remove the damaged wood siding, and check the underlying wall studs and sills for hidden rot; Repairing these sections is important to protect the building framework from water penetration and prevent further structural decline.

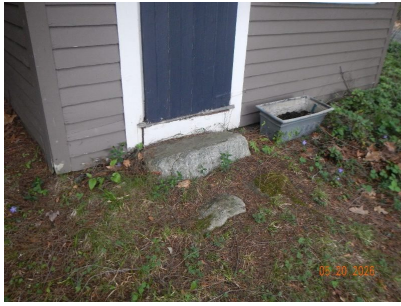
~Shed Stone Step Settlement: Observation of the shed entrance identified that the stone step has settled and is uneven; It is advised to reset and level the stone step onto a proper, compacted gravel base; Correcting this settlement is important to eliminate a safe-stepping hazard and prevent the stone from shifting further or trapping moisture against the shed foundation.

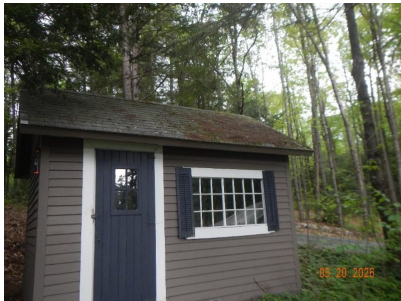
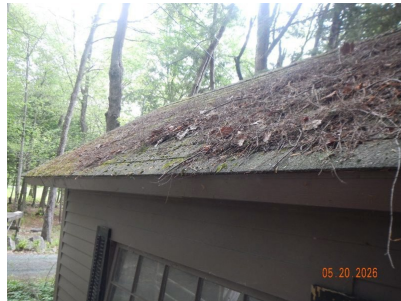
~Shed Roof Maintenance and Aging: Observation of the shed identified that the roof shingles are nearing the end of their useful life and have a heavy accumulation of debris; It is advised to have the roof surface thoroughly cleaned and professionally reviewed by a roofing contractor; Completing this inspection is important to determine the remaining lifespan of the shingles and prevent unexpected water leaks.

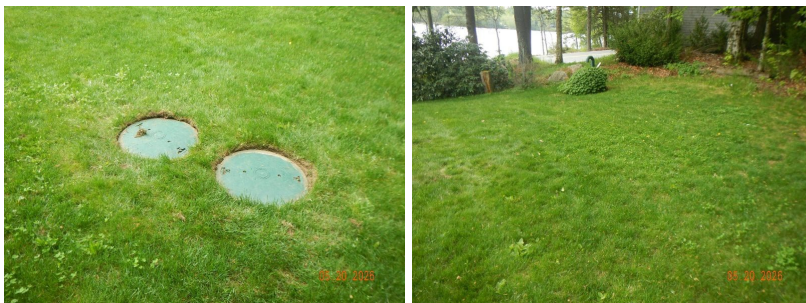
~Private Septic System Pre-Listing Status: Observation of the home identified that the interior drains are flowing properly with no unusual septic odors present; However, a full evaluation of the exterior components—including the septic tank, distribution box, and leach field—is outside the scope of this inspection; The seller is advised to have a licensed septic professional verify the exterior system's functionality and document the tank's current condition and pumping history; Adding these verified service records to the Home Information File is recommended to provide clear documentation for the next owner.

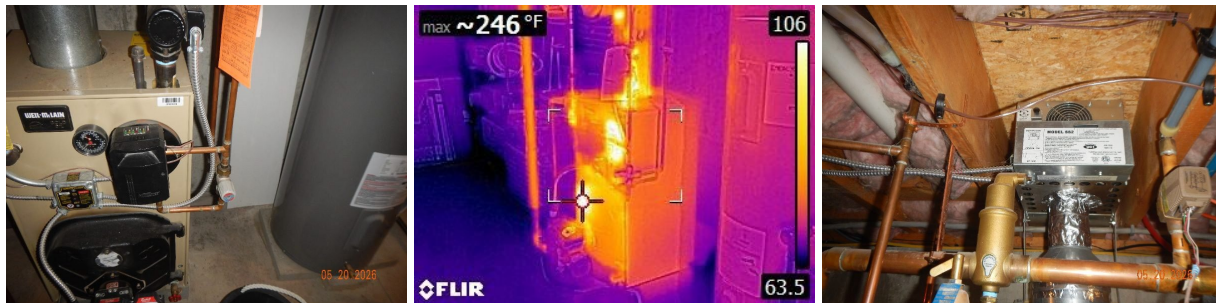
IR Boiler Operation

~Boiler Service and Operational Status: Observation of the heating system identified that the boiler is operational, heating properly, and was recently serviced on 5/26 of this year; It is advisable that this equipment continue to receive professional maintenance on a yearly basis to ensure power vent exhaust safety and peak energy efficiency; It is recommended to place the recent service receipts, contractor contact details, and service plan information (if available) directly into the Home Information File to document its current maintenance status.

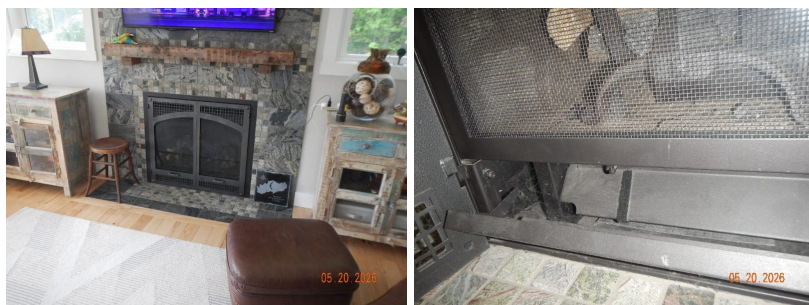
~Gas Fireplace Cleaning and Service: It is recommended that the gas fireplace be professionally serviced prior to placing the home on the market; This maintenance should include a thorough vacuuming of dust below the unit, cleaning the glass front, and a full inspection of all exhaust components; Placing the service receipt directly into the Home Information File is advisable to document that the unit functions safely and operates efficiently.

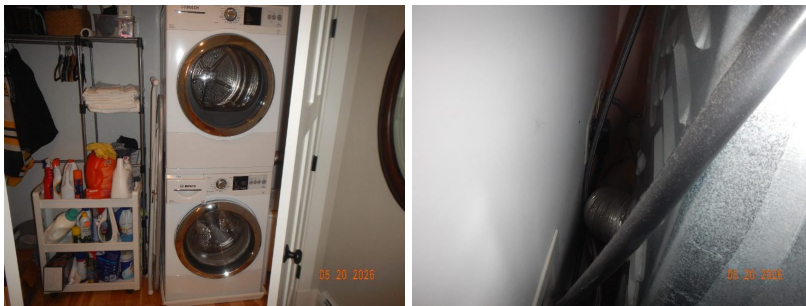
~Important Fire Protection Maintenance: At Move In And Ongoing: Washer and Dryer Behind and Under Unit Clean-up: An important maintenance task for fire prevention, the areas behind the washer and dryer cleaned and vacuumed of all lint, dust and objects that find their way behind the units over time; The dryer vent and all connecting venting hoses should be cleaned and if plastic vent pipes discovered replaced with metal and the termination point outside the home confirmed; The clothing washing machine plumbing and drain connections should be reviewed for proper installation and shut off ability; The clothing washing machine is not tested as part of the inspection due to the possibility of leaving water in the unit; Verification of the units operability should be made with the seller if the unit is part of the sale.

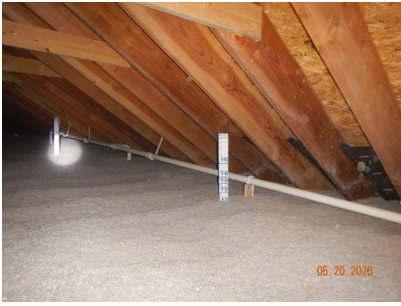
~Attic Insulation Present: Observation of the attic space confirmed the presence of blown in cellulose insulation with an estimated R-value of 30 (confirmation of the actual R-value will need to be made at the energy audit); This current level is below the newer recommendation of R-49 for this region; It is recommended that a professional insulation contractor be consulted to achieve the desired R-value; It is suggested that the new owners contact their local electric utility provider to discuss available programs or rebates to determine the best next steps for improving the home's energy efficiency.

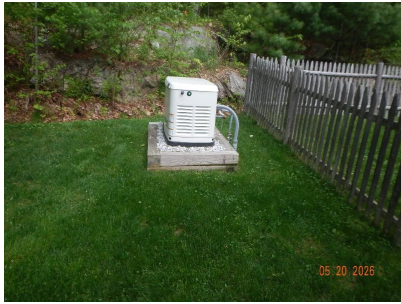
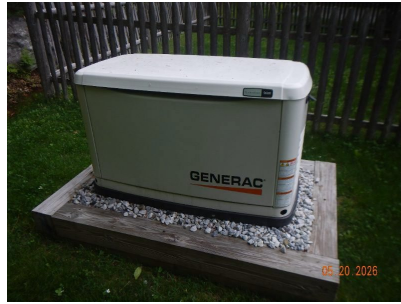
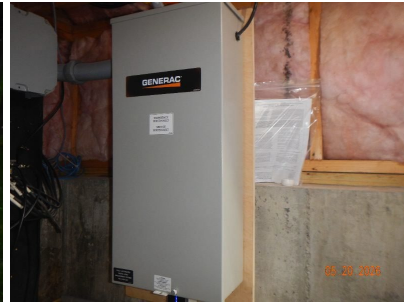
~Standby Generator: Auto Transfer Switch; Active Control Status: The home is equipped with a 16 kW propane fired exterior power generation unit and auto transfer switch gear at the electrical panel in the basement; The unit is inspected for exterior defects, vegetation blocking air intake ports, and last service date indications; The unit is not live tested as part of the home inspection scope; A licensed electrical contractor or service company servicing the generator should be consulted about the current service status and verification of the units operation, all connecting service wires, oil condition, the electrical circuits and systems supported by the generator and all transfer switching off and back onto the utility service; The service verification should be added to the Home Information File.
