# River Valley Home Inspections LLC

David M. DeSimone  
ID: Board Certified and Licensed in NH and VT  
244 Town Shed Road  
Orford, NH 03777

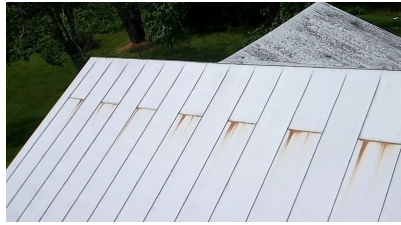
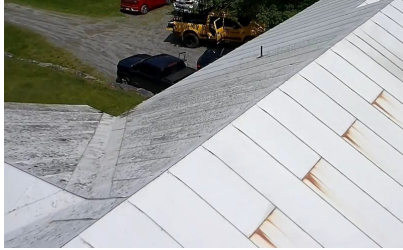
~Standing Seam Galvanized Metal Roof Aging: Observation identified that the standing seam galvanized metal roof is in generally good condition but showing signs of wear and surface damage from age and weather impacts; Options to clean, reseal, and recoat the roof panels should be explored to extend the life cycle of the roof covering; It is recommended that a qualified roofing contractor evaluate the installation and perform necessary restoration maintenance.

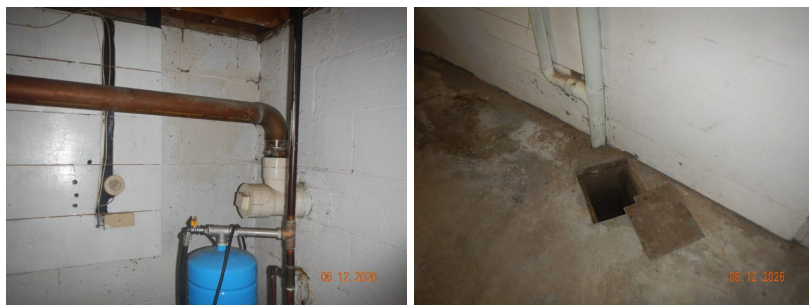
~Private Septic System Evaluation: Two Exit Point From The Home: This observation indicates that at the time of the inspection, the interior portions of the septic system are functioning with adequate drain flow and no unusual septic odors within the home; However, a comprehensive evaluation of the exterior components is outside the scope of this inspection; A licensed septic professional must be consulted to verify the integrity and functionality of the septic tank, the distribution box, and the leach field; This assessment should include an inspection of the piping and a review of the tank's current condition and pumping history before taking possession of the home.

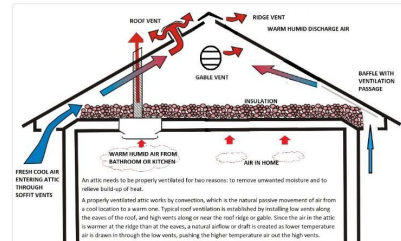
~Attic Ventilation: Observation of the attic space confirmed that the existing soffit vents are blocked or improperly installed; To provide the best venting condition, the installation of attic soffit baffles and properly sized gable end venting or an alternative method is recommended to allow heat to move effectively out of the space during summer months and moisture in the winter; It is suggested that a professional insulation and venting company be consulted to correct the airflow and ensure the attic remains dry and well-ventilated.
